12 BRIDGE CORNICE WITH GRC LOST FORMWORK

SUMMARY: There are several road and highway bridges currently under construction in the Czech Republic that will have cornices composed of GRC lost formwork connected with cast-in-situ concrete inside. The reasons are both aesthetical and technical (easy assembly, higher resistance against the aggressive environment). To verify the behaviour of the composite GRC with normal concrete, we are doing special research into its properties. The final task will be the manufacture of an experimental bridge cornice 8m in length, composed of these two materials. The cornice contains everything a cornice actually built on a bridge would, including anchoring elements to the superstructure and steel barriers. The experimental cornice will be cut into many specimens and a wide range of tests will then be carried out – strength in compression, bonding strength between GRC and normal concrete, resistance against chlorides, creep and shrinkage of the composite, pressure of steam in the contact between the two materials, and so on. The results will ultimately be used for the design of the actual cornices on the bridges.

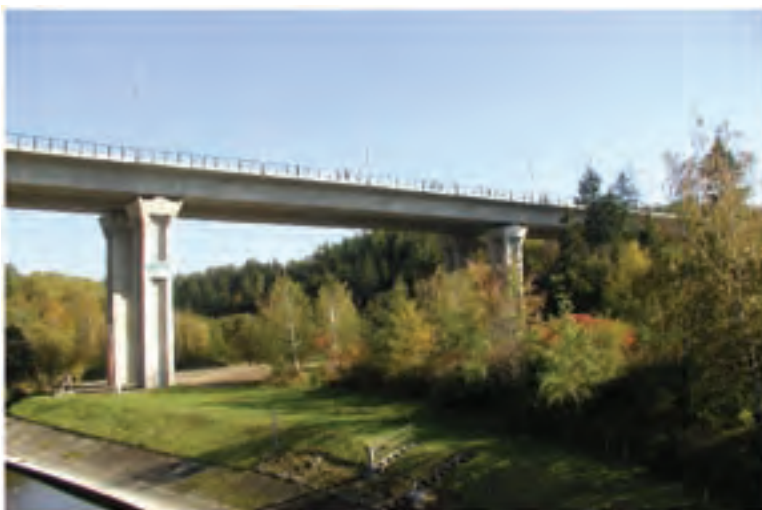
Figure 1 - Bridge in Plzeň with GRC lost formwork of pier heads

- As a lost formwork for bridge piers with quite a complicated shape (e.g. bridge in Plzeň, Figure 1)
- As a lost formwork for the creation of the internal shape of deviators for external prestressing reinforcement (SMP segments, since 2002, Figure 2)
- As a lost formwork for bridge parapets with imitation of natural granite (e.g. a bridge in Vsetín, Figure 3)
- As a non-composite cornice panel (e.g. a bridge in Brno)
- As a part of composite cornices acting together with cast-in-situ concrete (e.g. bridges in Frýdek – Místek, Figure 4, in Zářečí and bridges over Odra river).

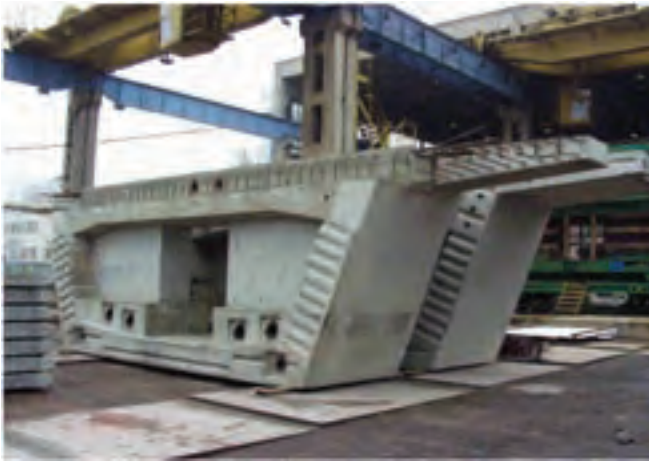
Figure 2 - Segments SMP with GRC internal lost formwork of deviators

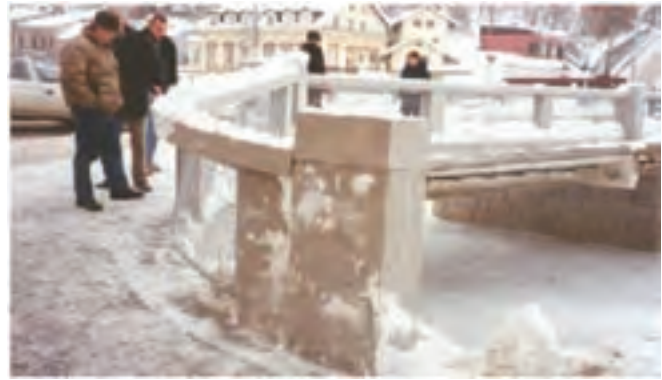
Figure 3 - Bridge in Vsetín with GRC lost formwork of parapets imitating natural granite

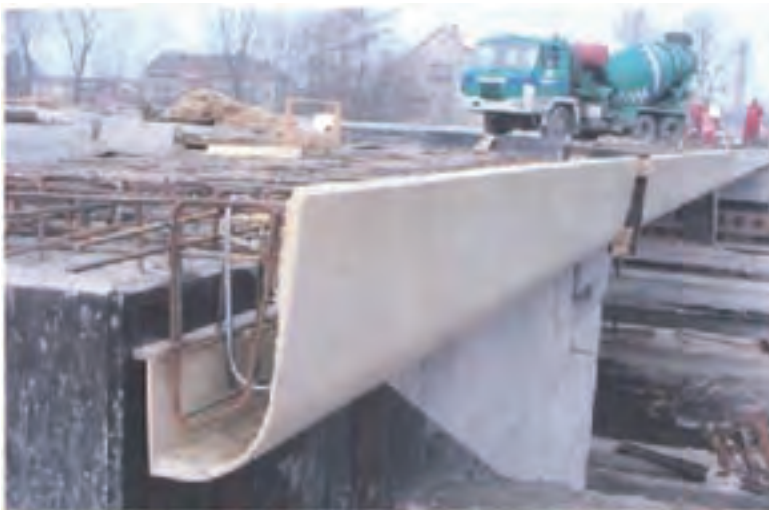
Figure 4 - Bridge in Frýdek – Místek with GRC lost formwork of composite cornices

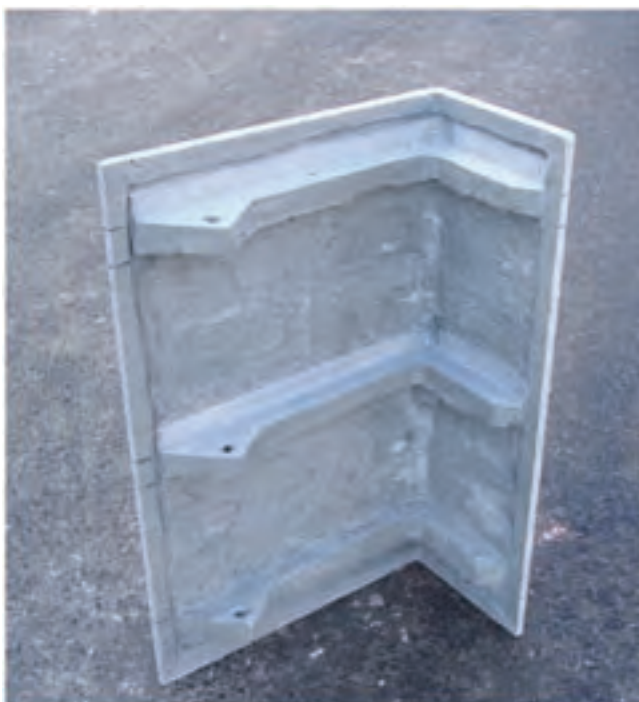
Figure 6 - GRC lost formwork of the composite test cornice

- basic reinforced concrete plate
- GRC lost formwork of the bottom and of the lateral part of the cornice (Figure 6)
- cast-in-situ concrete.

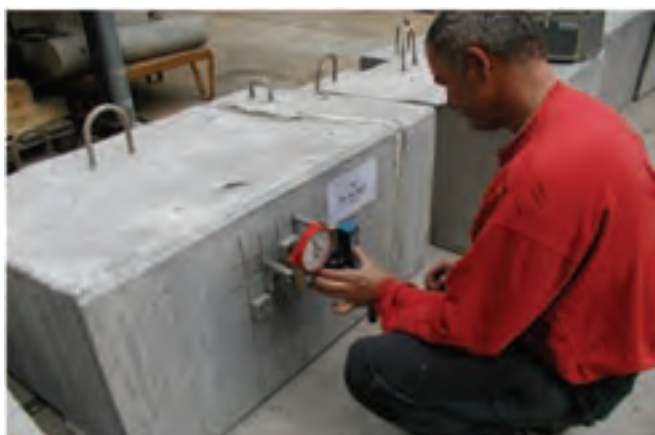
Figure 7 - Bonding strength test on a part of the test cornice Figure 8 - Specimen after a bonding strength test

- bonding strength between GRC and cast-in-situ concrete (Figure 7)
- pull-out tests of chemical anchors, which can be used, for example, for fastening noise barriers
- grouting of non-concreted internal spaces, which can be created by bad pouring and handling of fresh concrete. For this reason, artificial internal spaces were prepared with parts of polyethylene bottles
- penetration of chlorides to the reinforcement of the cast-in-situ concrete through the GRC
- repair of damaged GRC elements.
