16 Keynote: GRC for the Restoration of Historic Buildings

Carl Stein
Elemental Architecture, USA

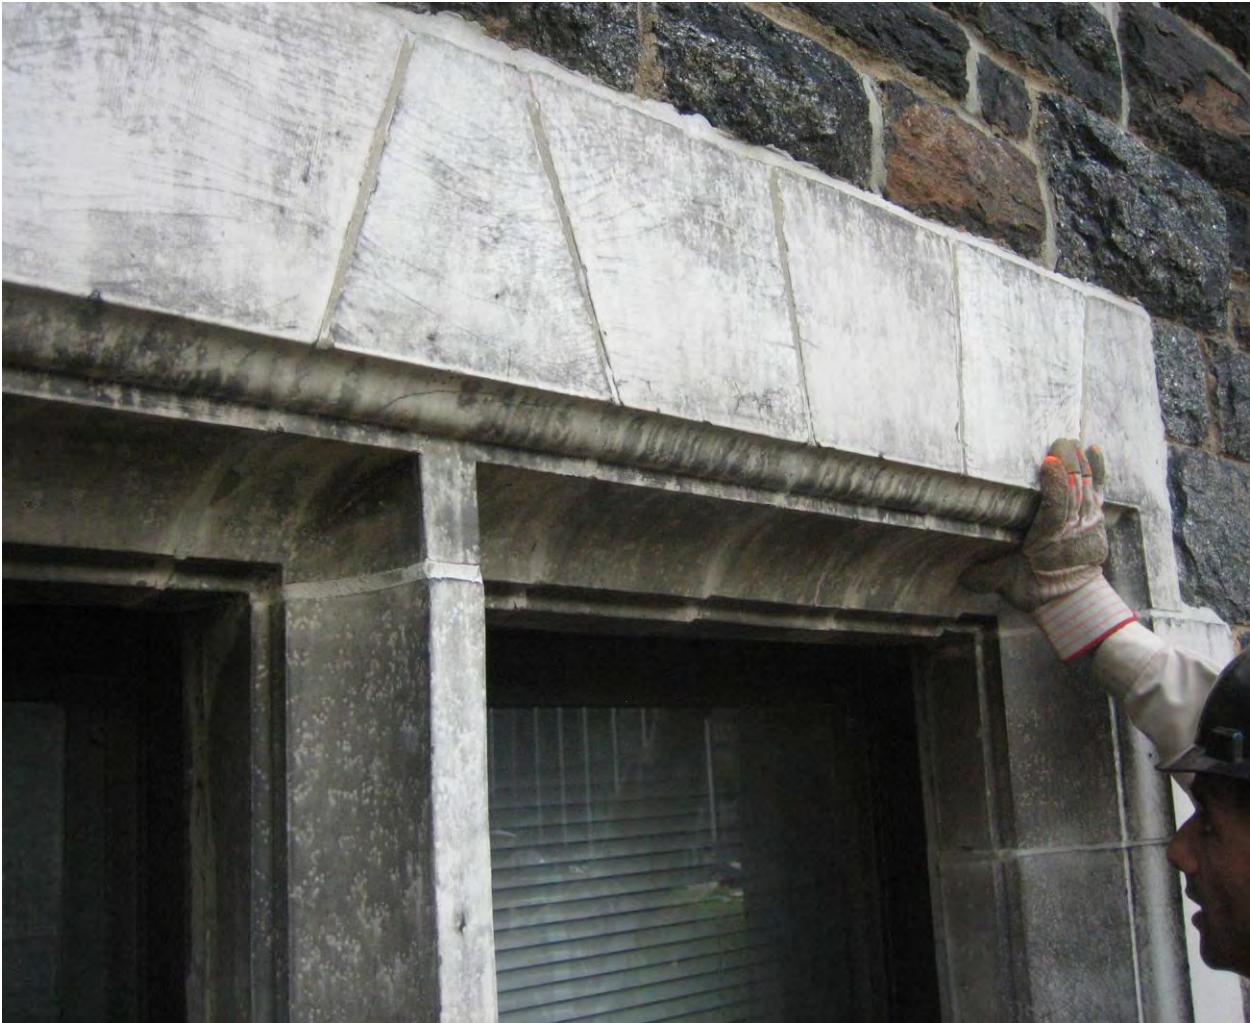
The terra cotta units ranged from flat panels and simple extruded moldings...

Figure 02 - Flat and simple extruded terra cotta

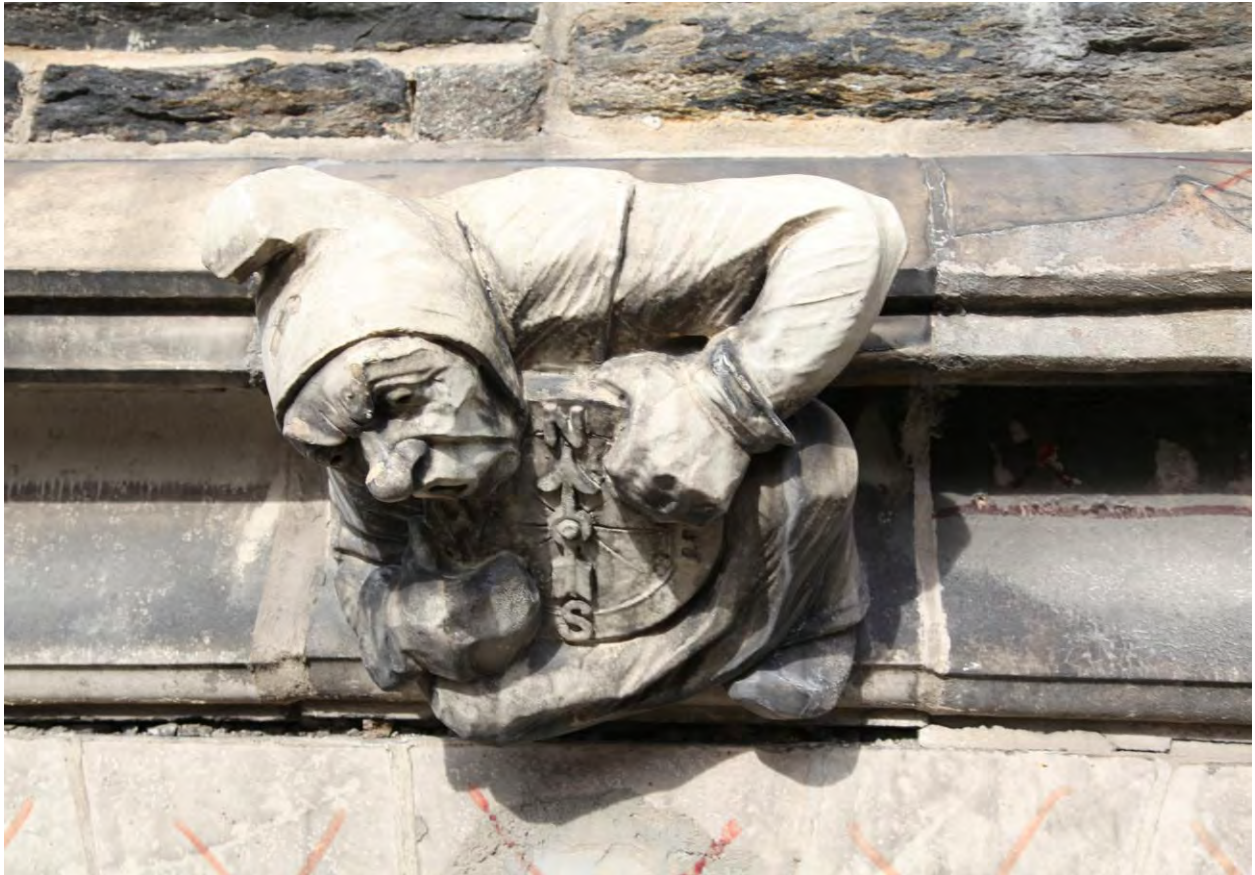
... to highly complex sculptures in the round, the largest being over 2 m tall.

Figure 03 - Surviving terra cotta sculpture

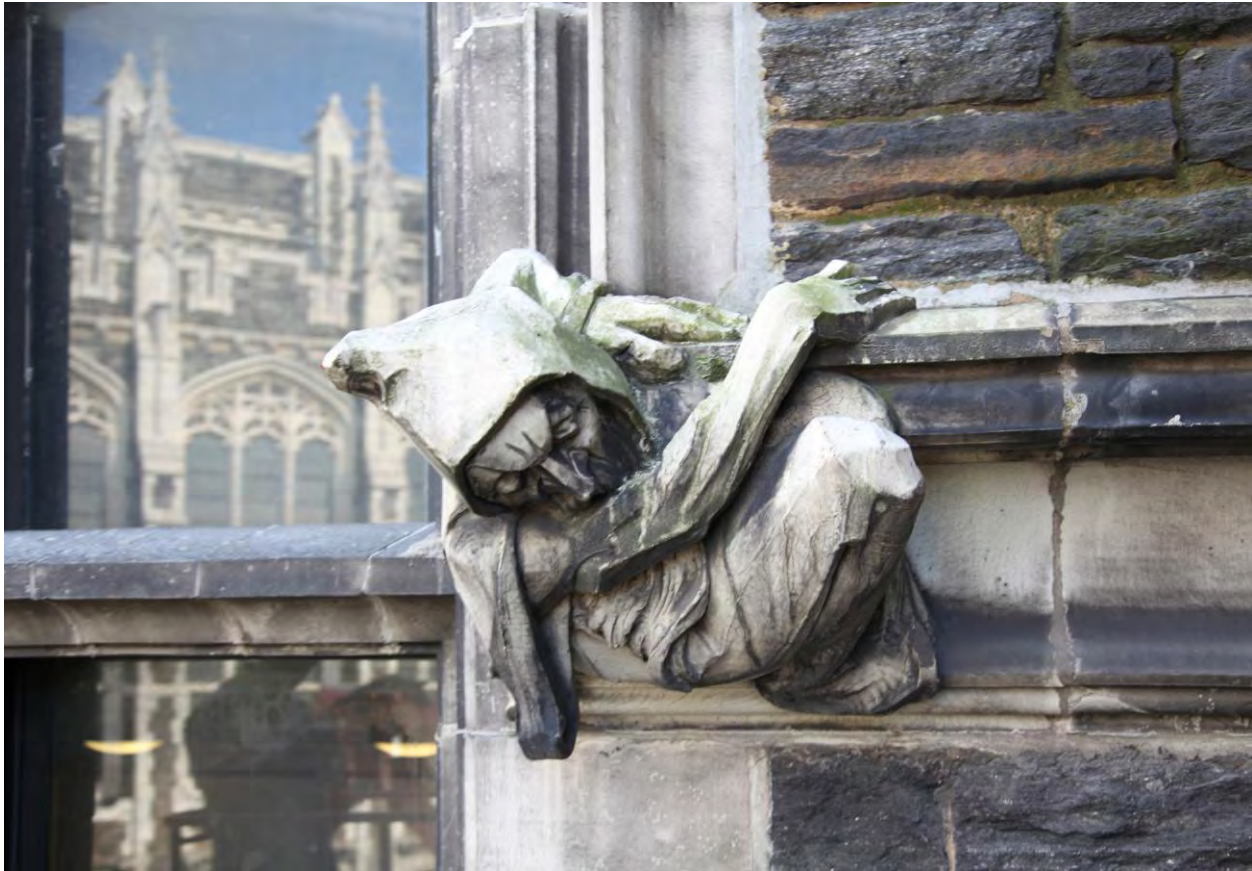
Figure 04 - Surviving terra cotta sculpture

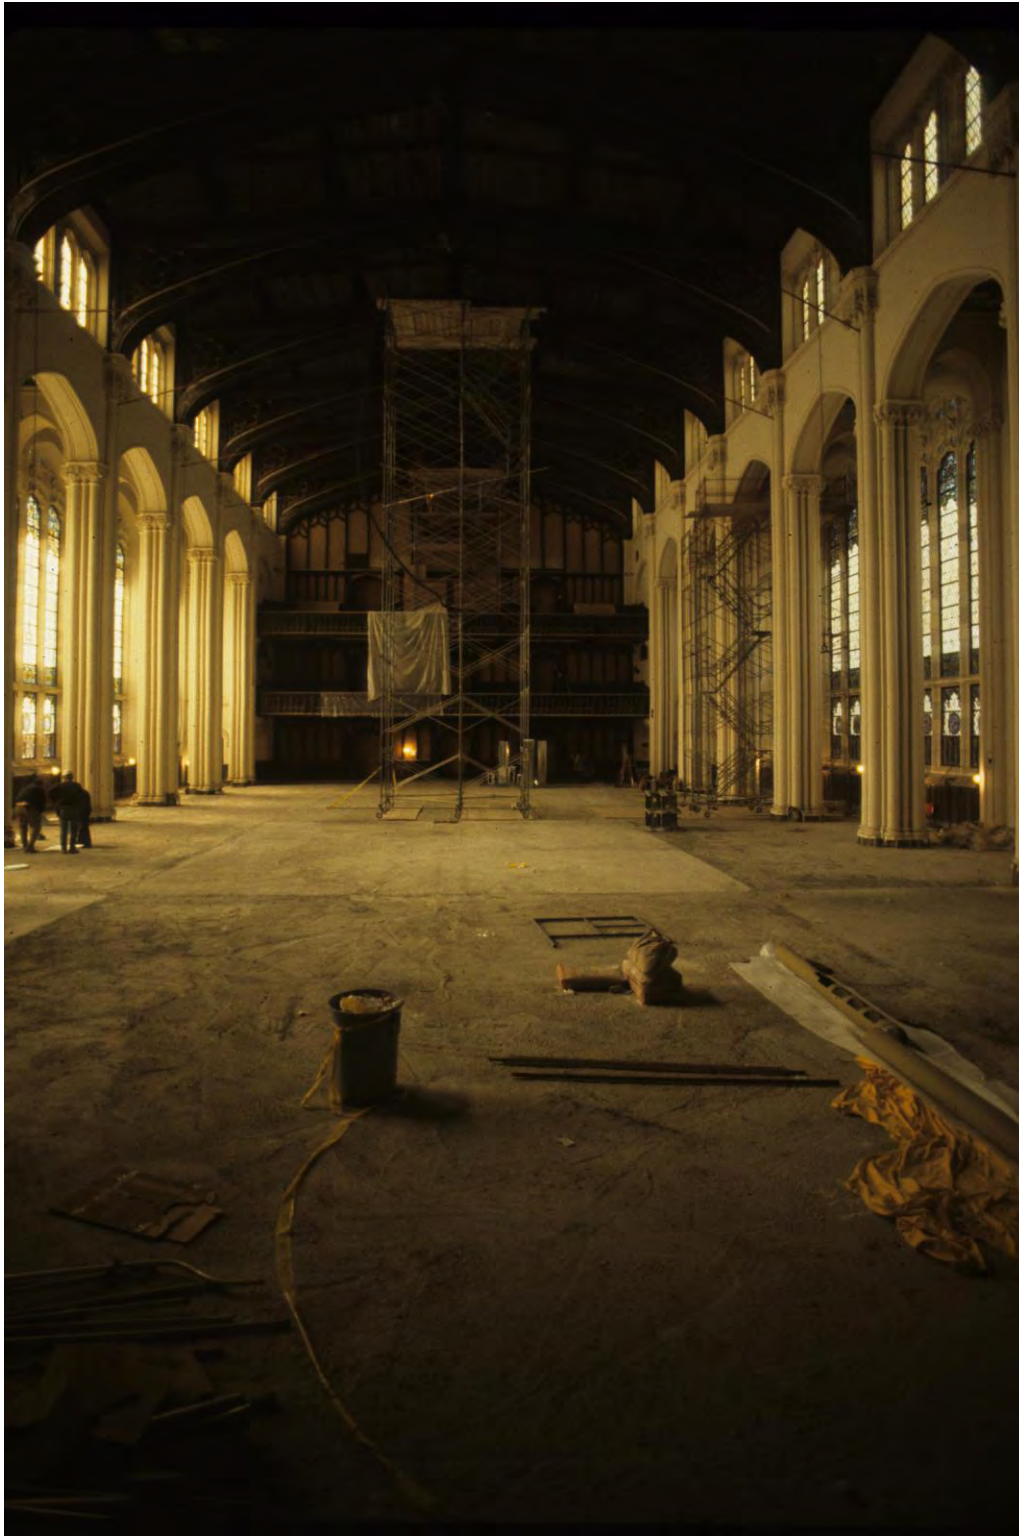
...the Great Hall has a floor area of 1,275 m² with ceilings 18 m high.

At the beginning of the project, the Great Hall was closed because fragments of terra cotta from the interior of the window tracery - each window being more than more than 12 m tall - had fallen to the floor and were considered to be significant threats to public safety.

- Figure 05 - The Great Hall prior to renovation
- Figure 06 - The Great Hall windows during renovation
- Figure 07 - The Main Tower prior to reconstruction

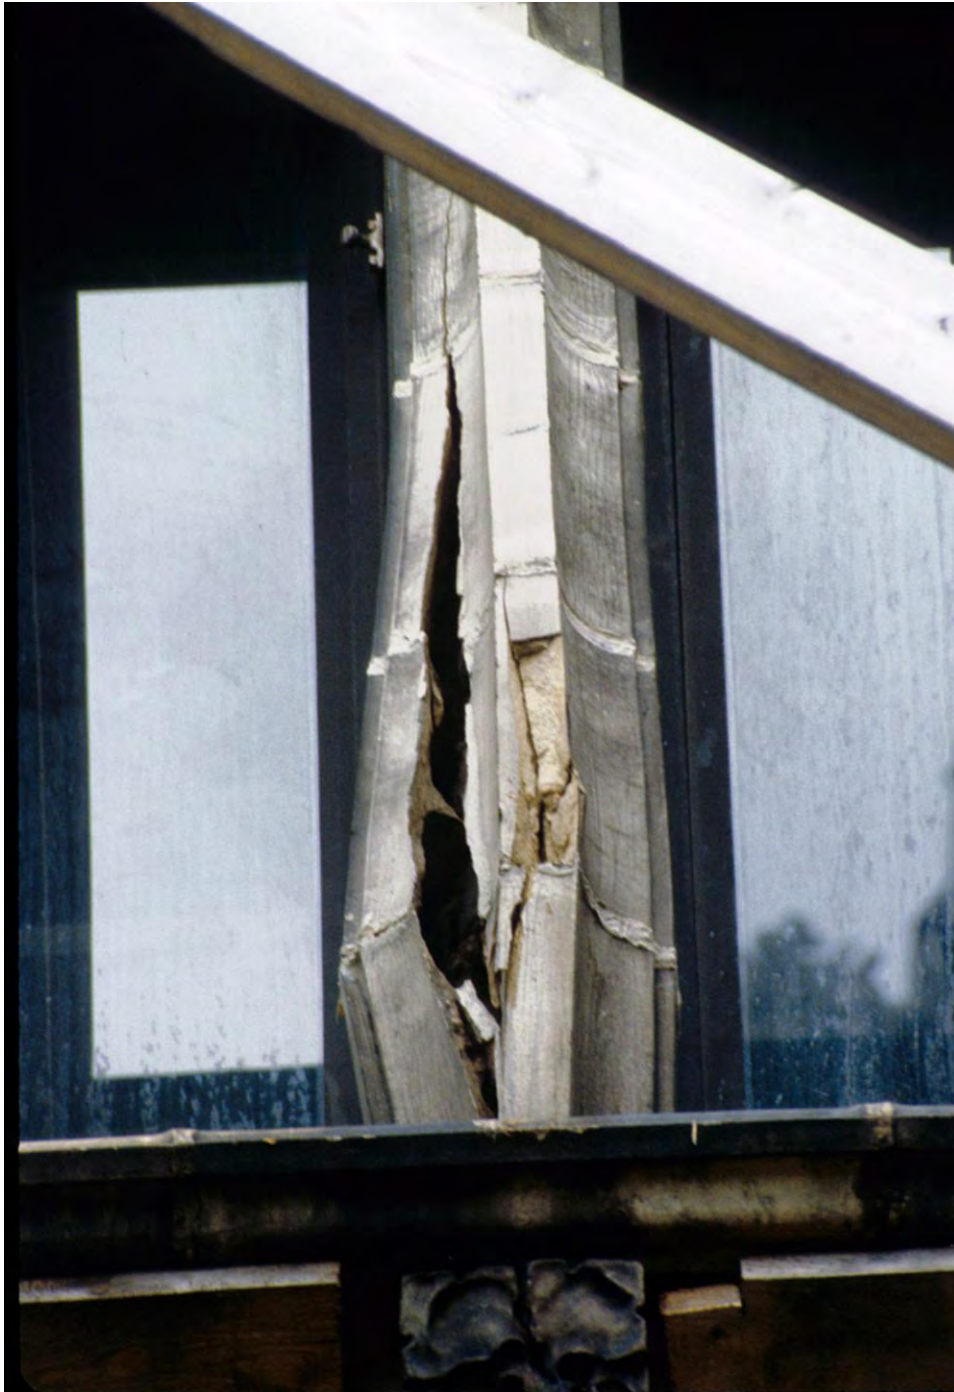
Prior to the start of the project, more than one third of the original terra cotta had failed, and been removed and replaced with brick and stucco.

- Figure 08 - Typical terra cotta compression failure at window tracery
- Figure 09 - Failure of temporary repair
- Figure 10 - Emergency installation of tension rods at Main Tower turrets

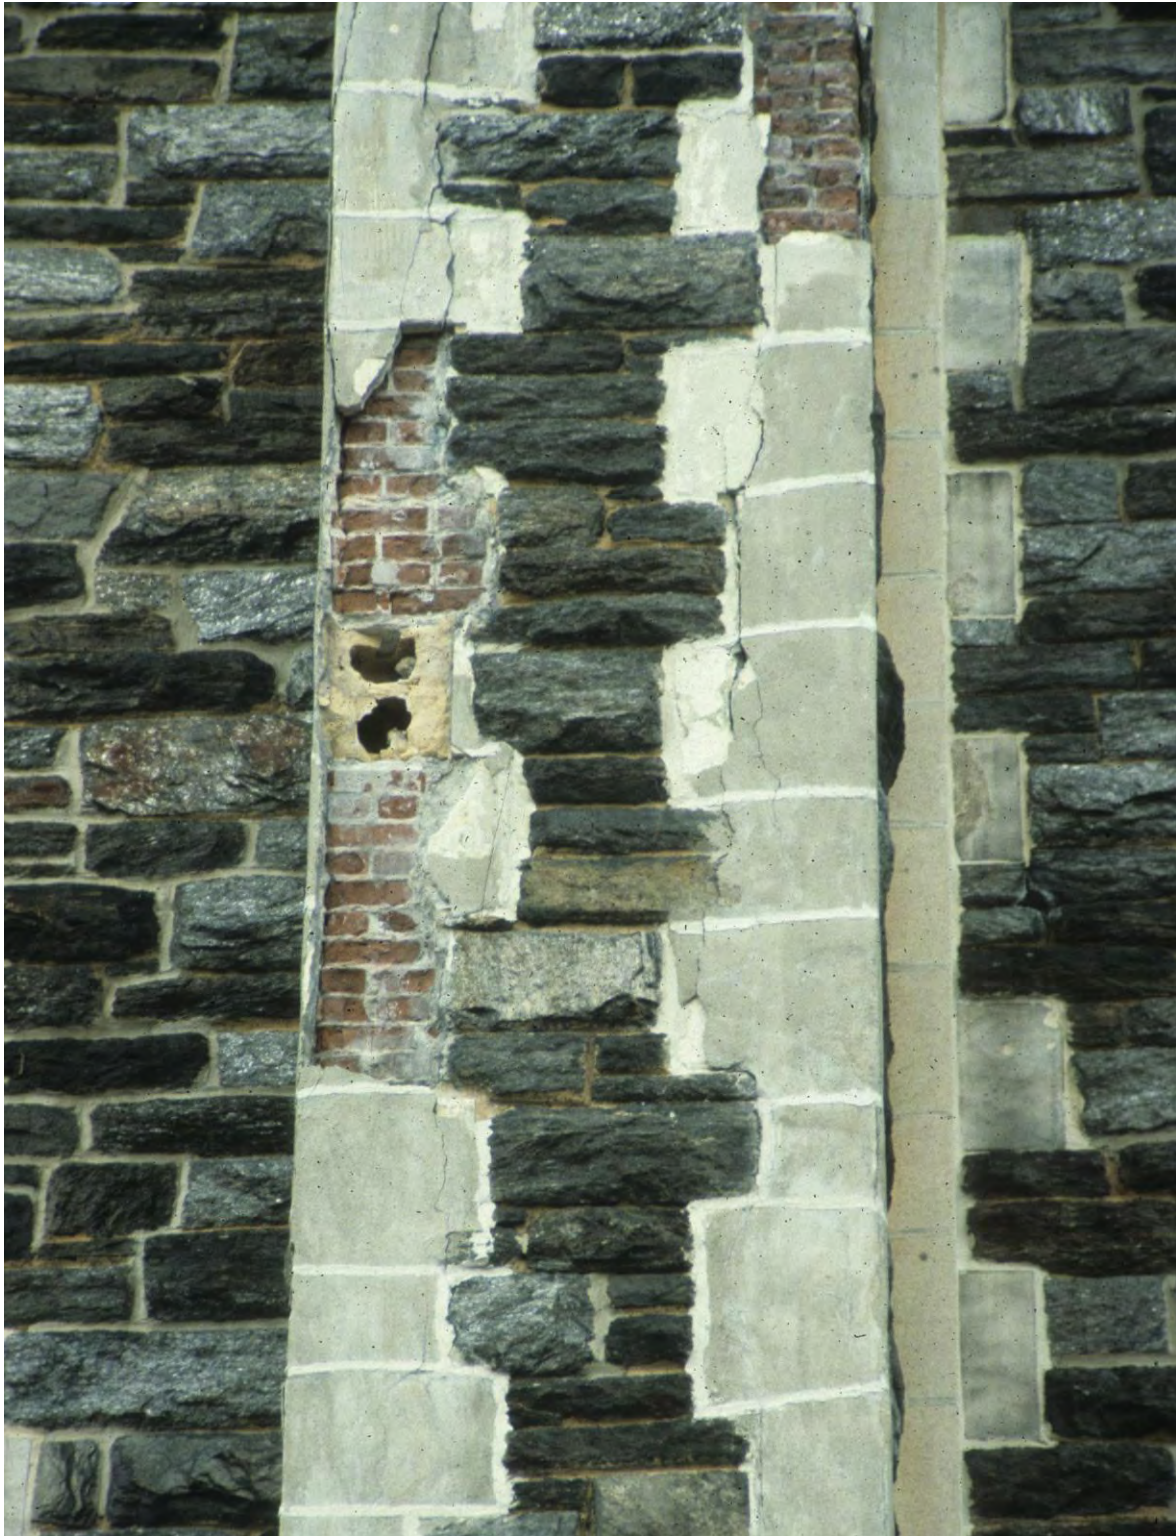
Figure 09

By 1986, a number of these repairs were, in themselves, already failing.

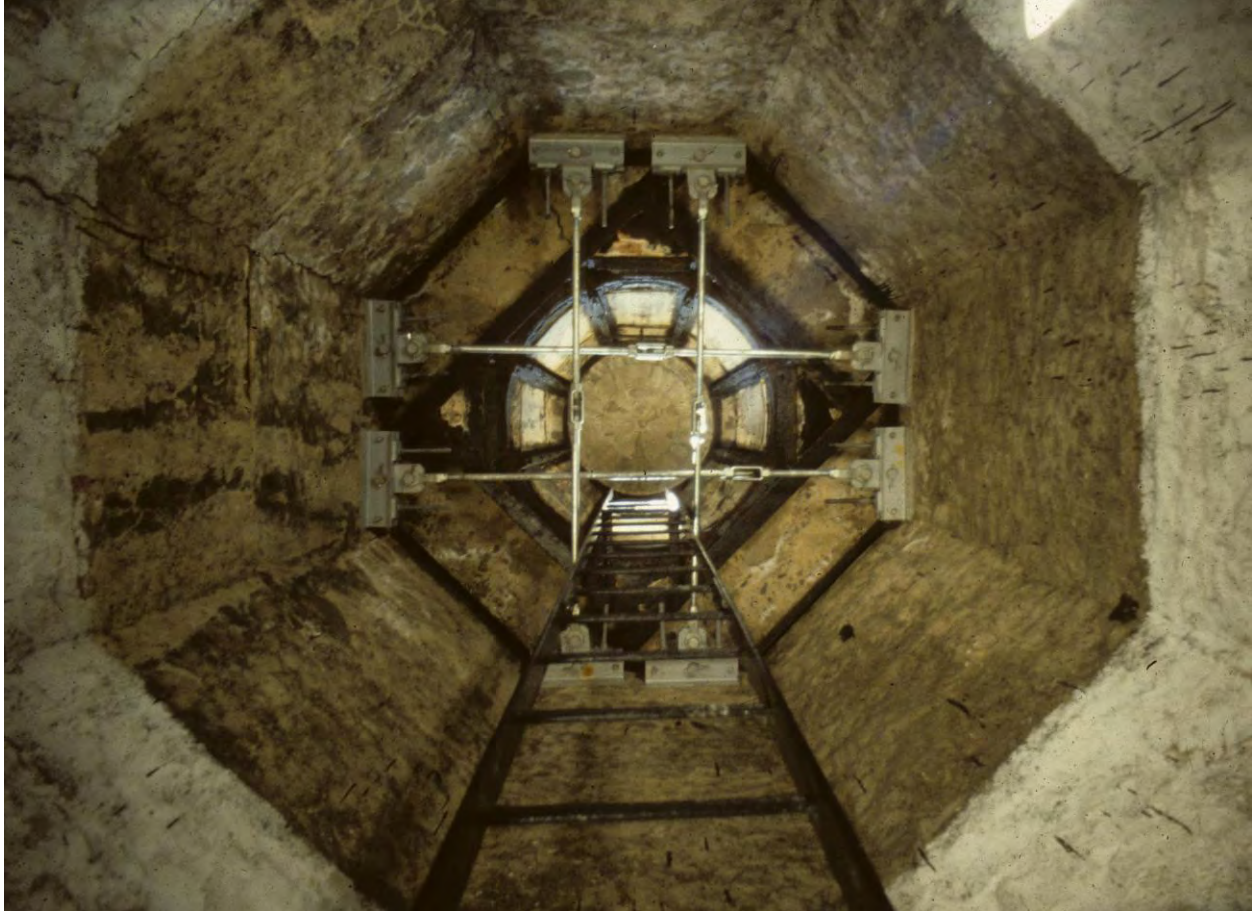
Figure 10

Of even greater concern was the fact that many of the steel members embedded in the masonry were exhibiting signs of failure and probes indicated that some of the steel had completely rusted away. Shown here are one set of the temporary tension rods placed through tops of the Main Tower turrets to prevent their collapsing outwards. Even these interim repairs added to the damage to the terra cotta ornamentation.

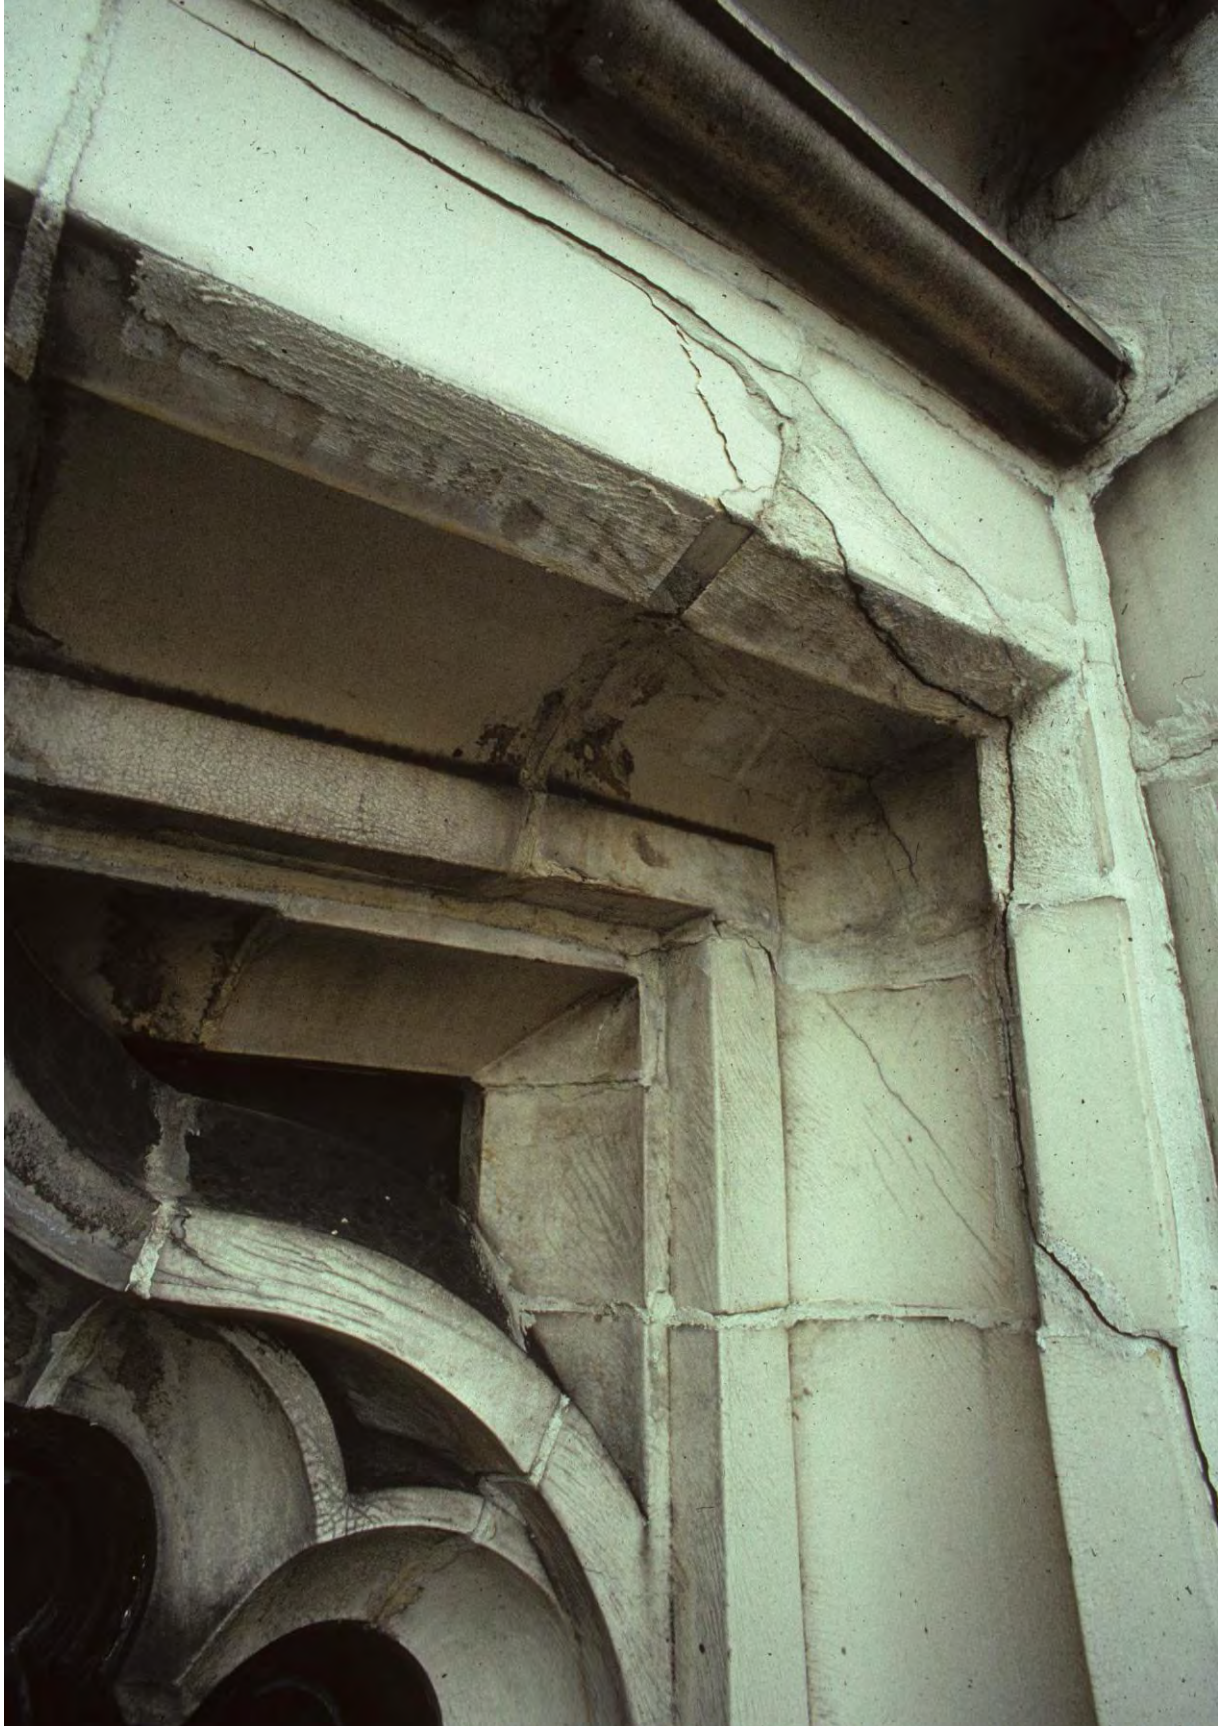
As the building moved, the terra cotta was crushed allowing water to attack the steel. Steel rusted and expanded increasing the openings and increasing the amount of water reaching the steel. In the winter, water freezing in the cracks exerted tremendous prying action causing sudden failures.

- Figure 11 - Fish plates for tension rods at Main Tower turrets showing damage to terra cotta
- Figure 12 - Typical terra cotta window surround showing cracking caused by building movement

The causes of the structural failures were manifold. Although there were some problems associated with manufacturing defects and improper installation of the terra cotta, a great many of the failures were due to the fact that the building was designed without expansion joints or other means to accommodate thermal movement, and, as noted above, the terra cotta was installed integrally with the stone.

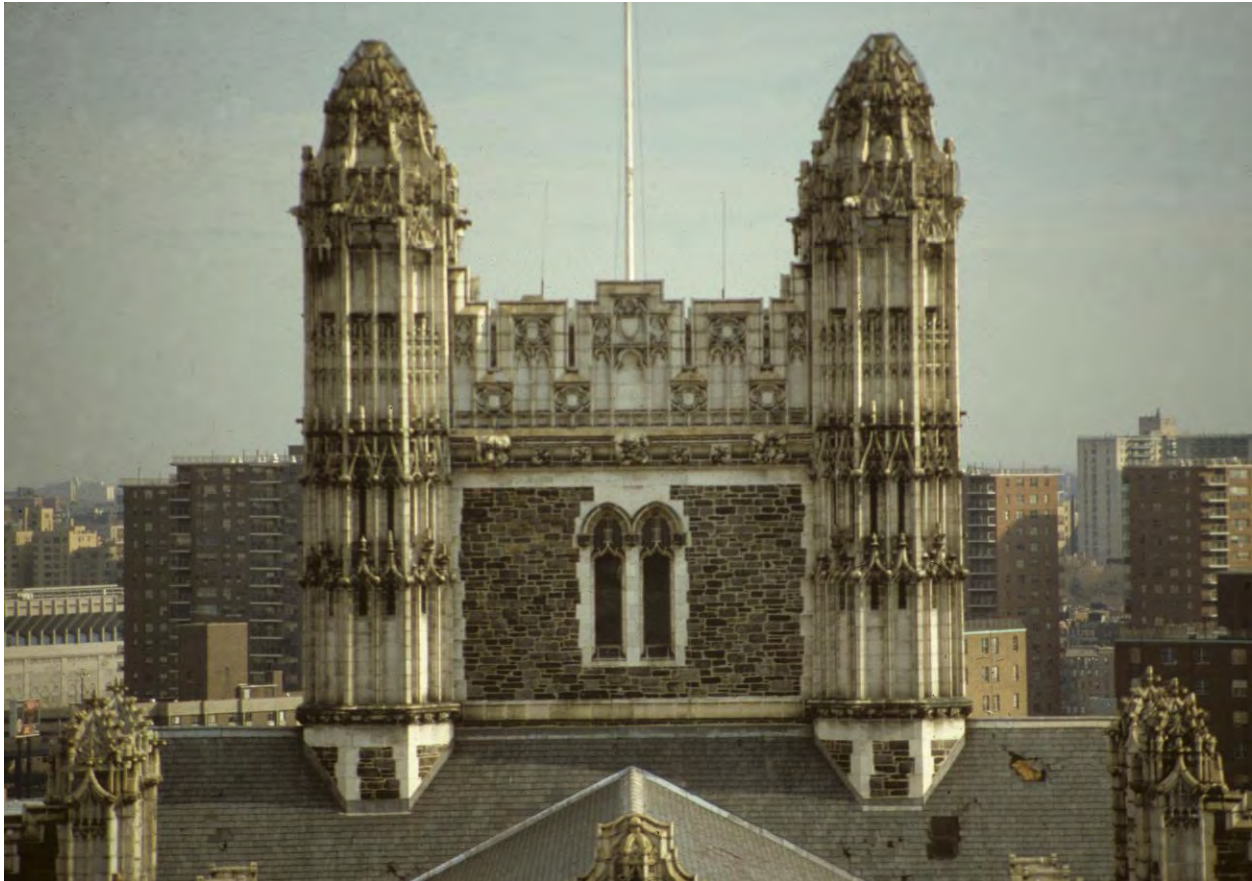
In some cases pieces of terra cotta weighing over 10 kg fell from heights of more than 30 m. Amazingly, no one was hurt, however areas of the lower roofs showed the effects of having been hit by falling debris, as can be seen in Figure 13.

- Figure 13 - Main Tower-Note damage to lower slate roof cause by falling terra cotta
- Figure 14 - Typical GRC joint details allowing movement
- Figure 15 - Overall view-Note all of the areas where building movement can be absorbed

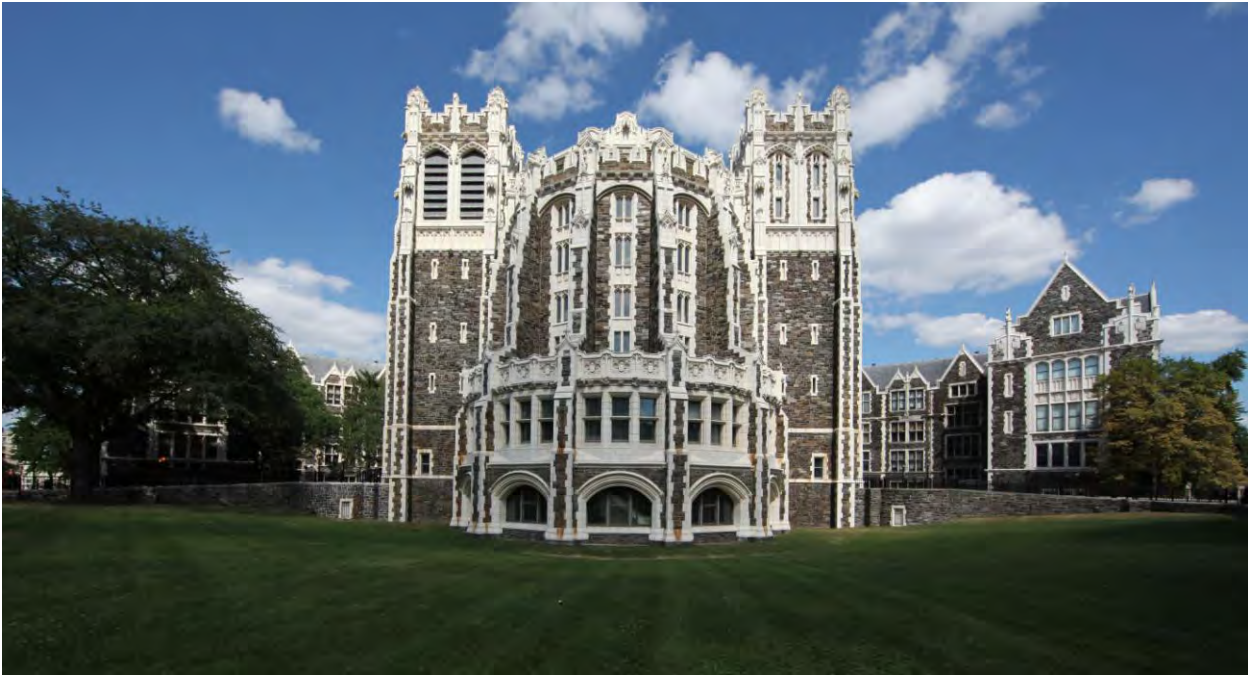
Figure 15

Since each field of GRC has multiple joints, the system utilized for the reconstruction of the decorative areas of the building is more than capable of absorbing all of the building movement. The extent of these de facto expansion joints, that is the areas having multiple soft joints between cladding units, can be seen in Figure 15.

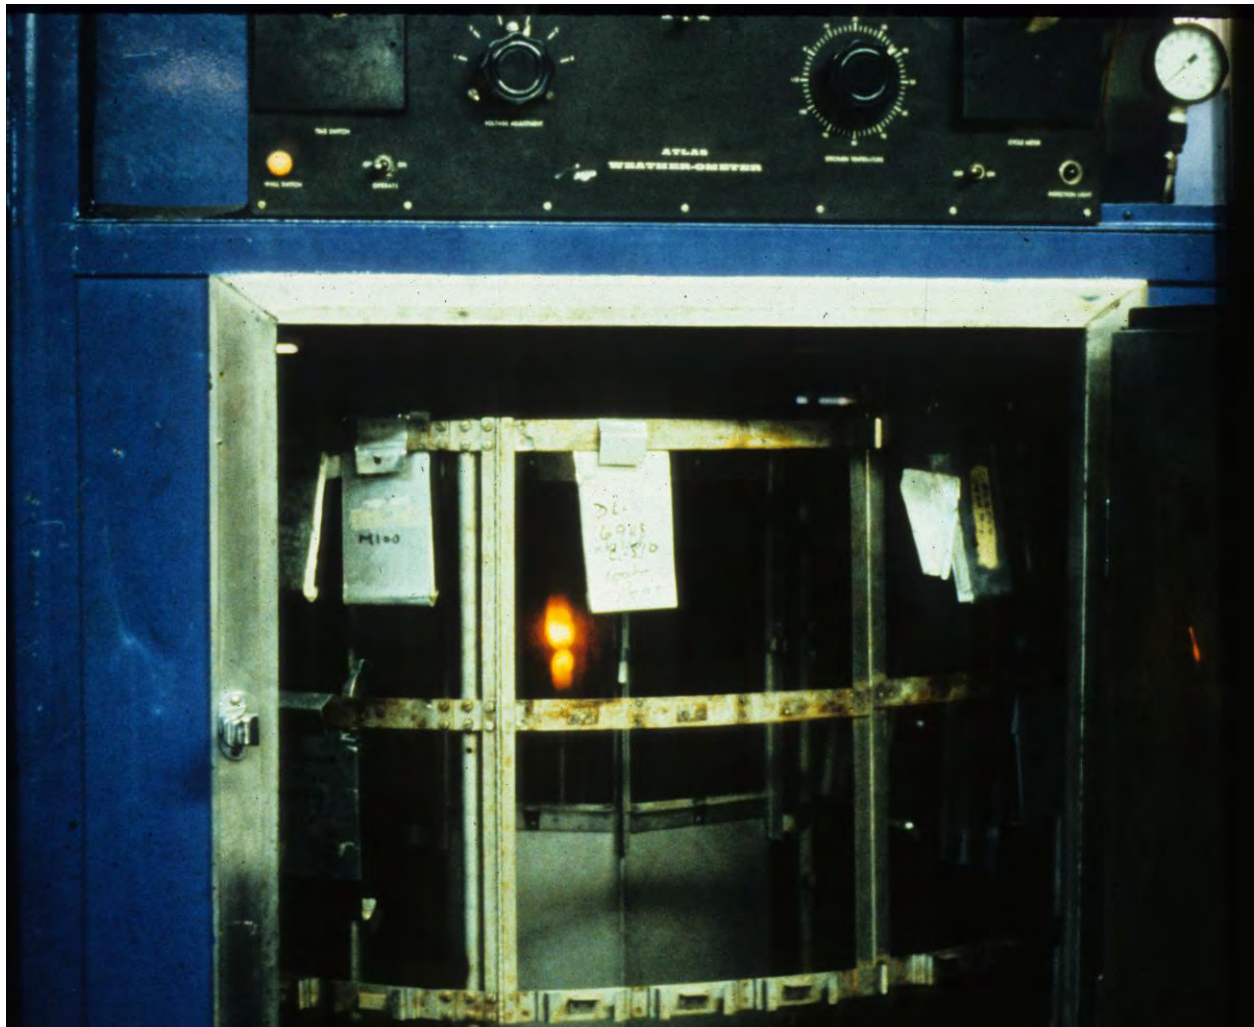
The Feasibility Study included several series of accelerated aging tests emphasizing the environmental stability of the surface and color properties of various glassfiber reinforced materials.

- Figure 16 - Environmental testing-UV weatherometer
- Figure 17 - Environmental testing-salt fog chamber
- Figure 18 - 1999 GRC
- Figure 19 - 1999 and 2001 GRC

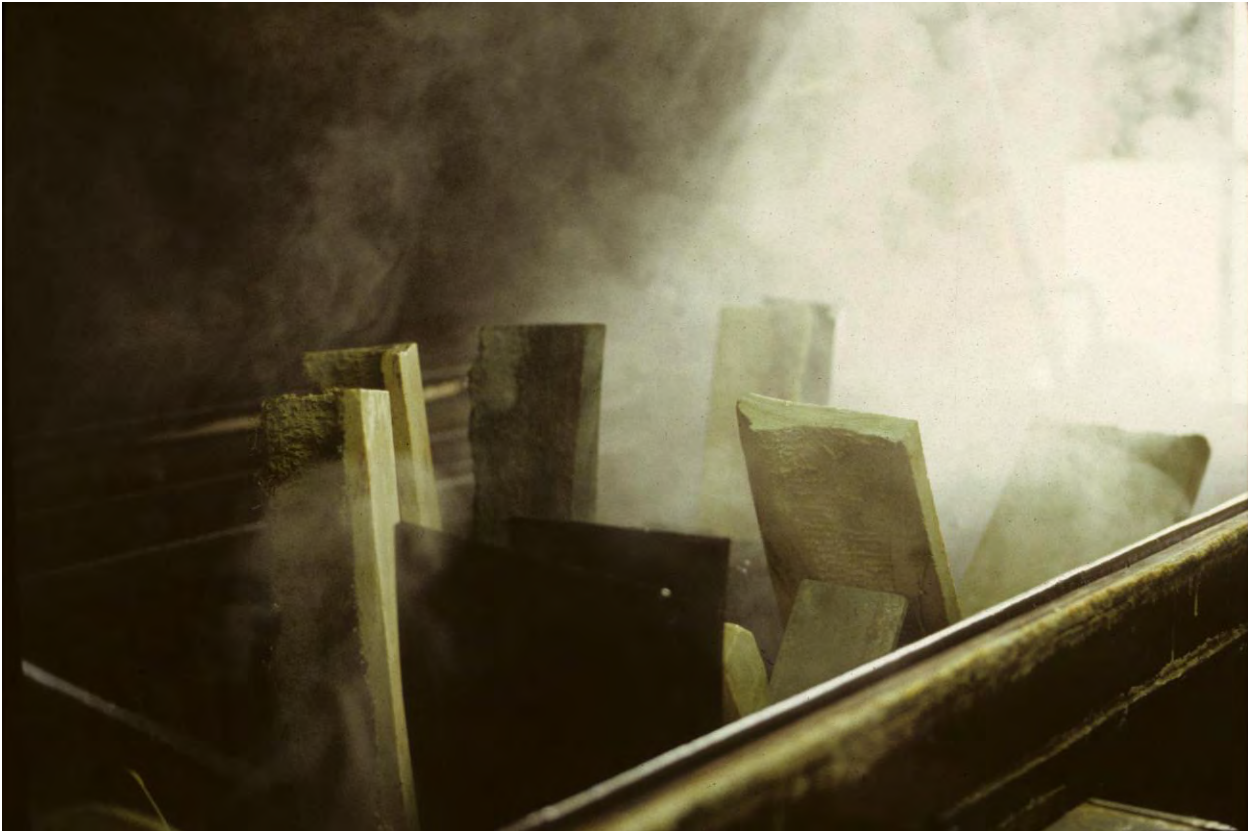
Figure 17

In the initial tests run in 1986, a proprietary system using a calcium alumina silica cement and E-glass showed clear architectural advantages. The first phase was carried out using this system. Now in place for more than twenty years, the product has performed well; however, it was difficult to manufacture and supplies were somewhat unpredictable.

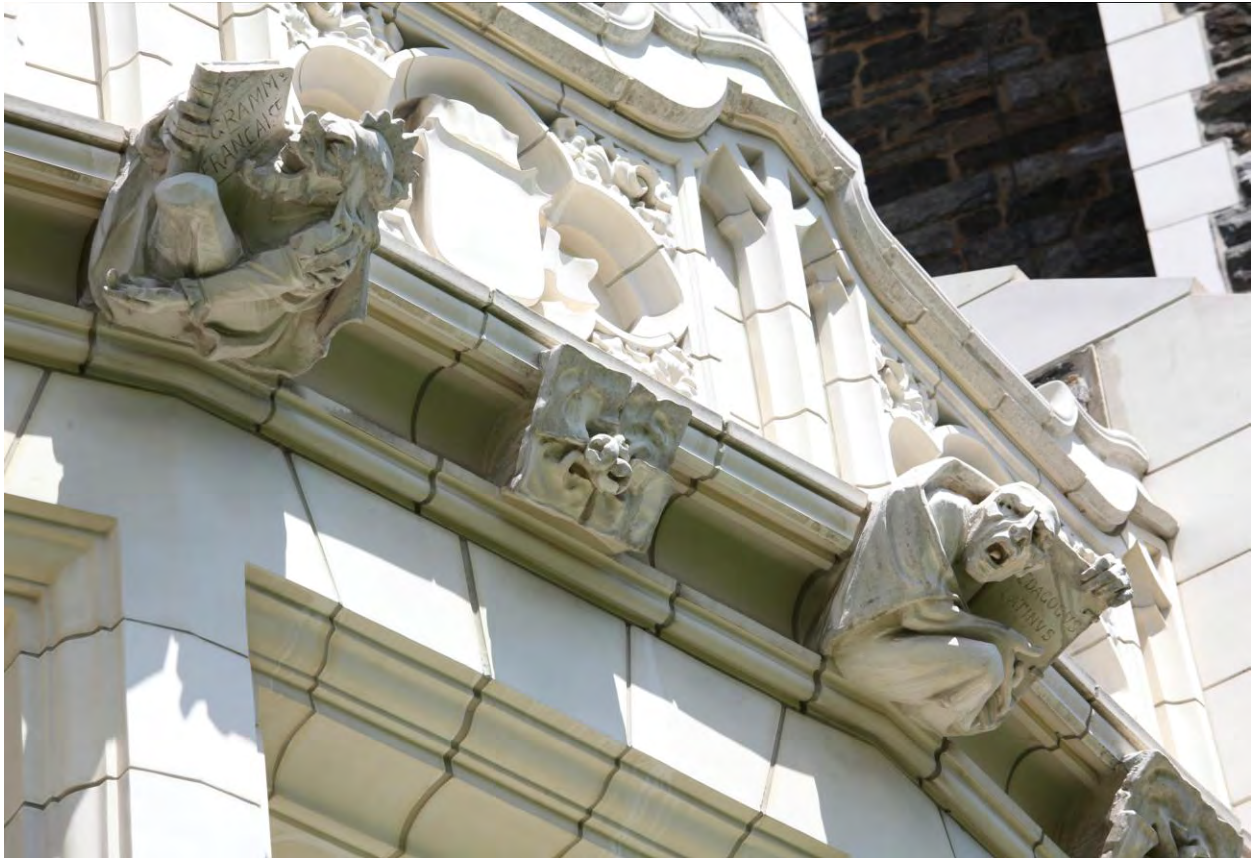
Figure 18

As the first construction phase was being completed in 1990, the client commissioned a new series of tests in order to determine whether a more readily available and easy to manufacture alternative could be found that would have comparable durability. Thirteen different GRC formulations were tested. One system incorporating metakaolin and small amounts of polymer tested significantly better than the rest of the samples. The finished surface was given an application of a breathable “neat” silane sealer to minimize dirt accumulation and to reduce the temporary color change when the material becomes wet. Other than this, there is no applied surface treatment.

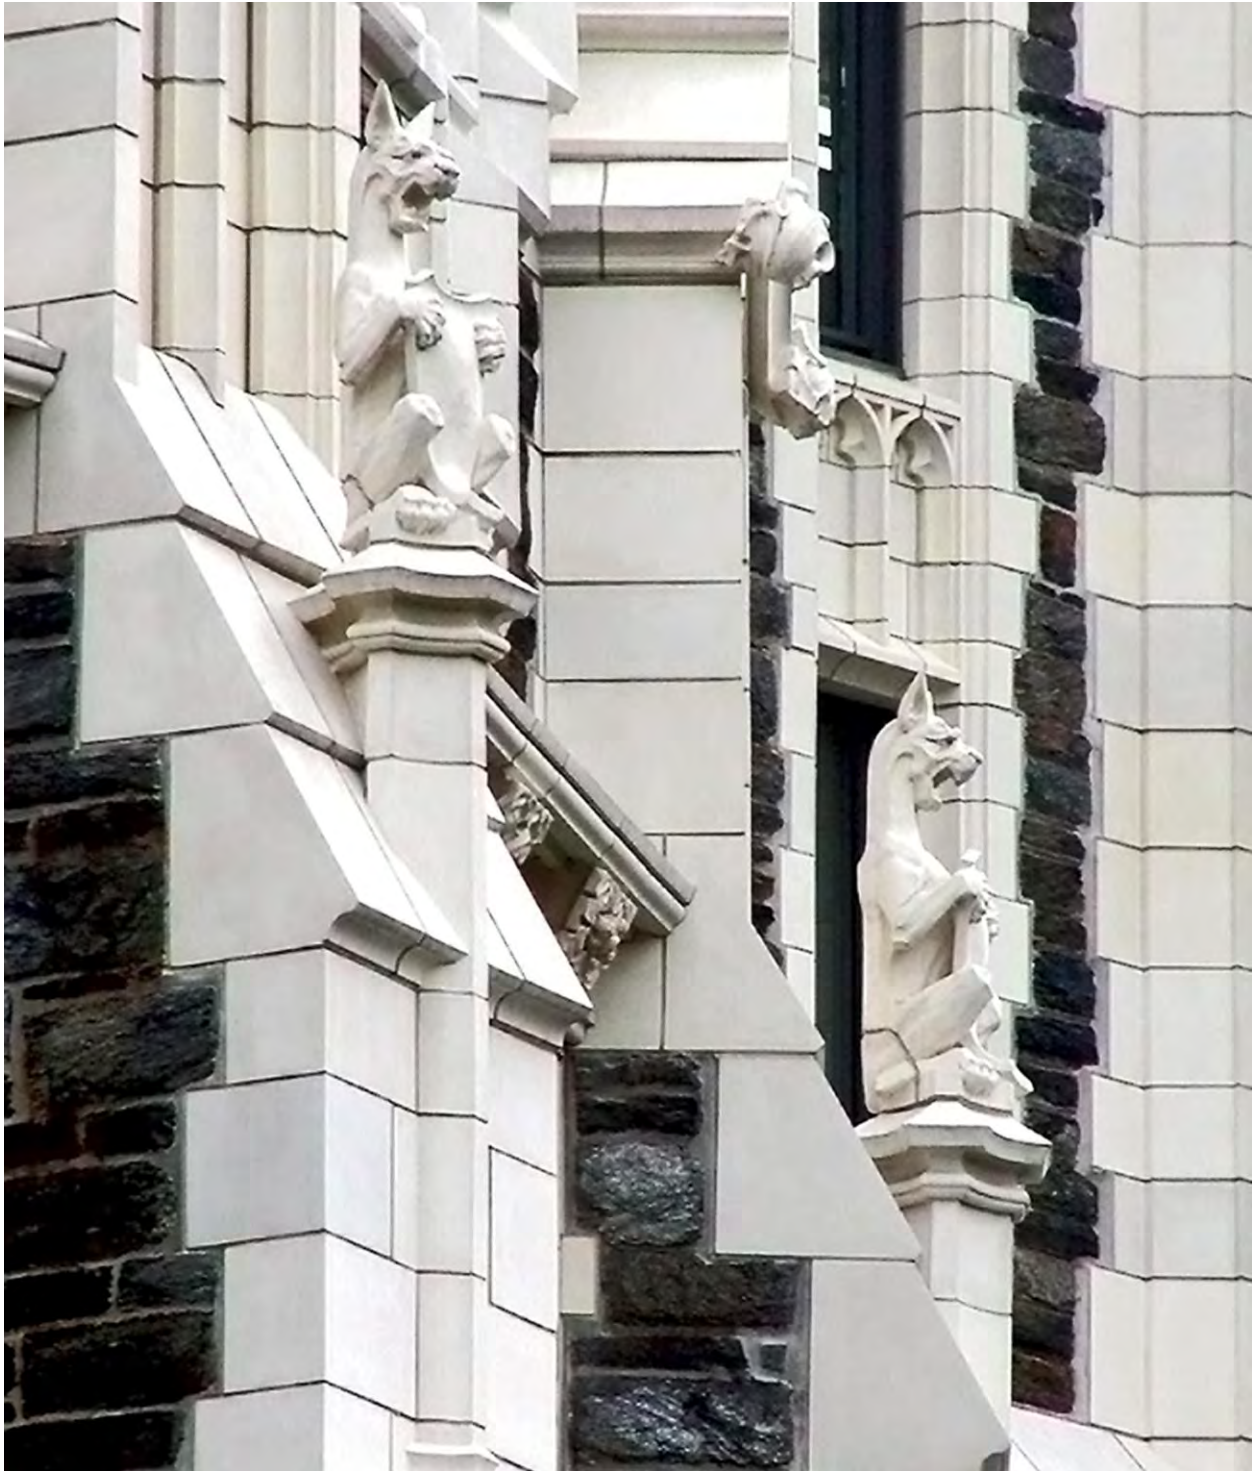
Figure 19

The GRC system described above was exclusively used for the next eight phases of construction and is specified for the ninth and final phase. The earliest installations of this material were in 1993. The

most recent were in mid-2011. Not including the first phase material, the GRC units have been produced by four different suppliers, fabricated at seven different production plants, and installed by three different contractors. There are areas of the building in which immediately adjacent GRC units have been installed more than fifteen years apart from one another.

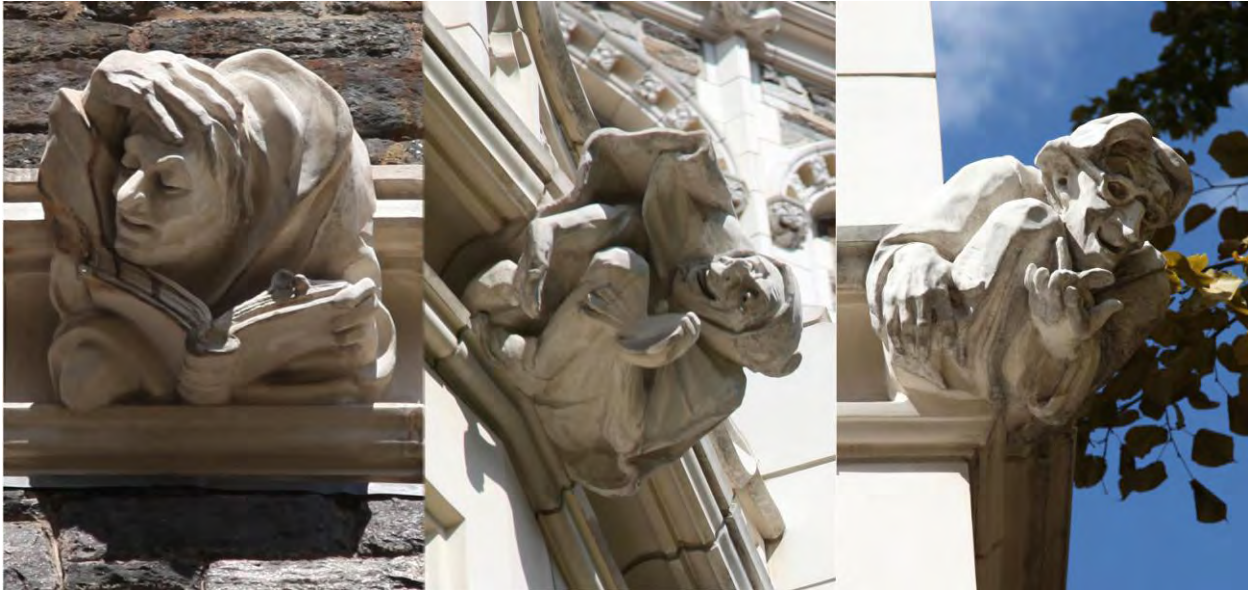
For example, the GRC at the left of this composite image was installed in 1995; the one in the middle in 1999; and the one at the right in 2005. Each was produced by a different fabricator.

- Figure 20 - From left to right, GRC from 1995, 1999 and 2005, produced by three different manufactures
- Figure 21 - Magazine article describing documentation processes developed for Shepard Hall

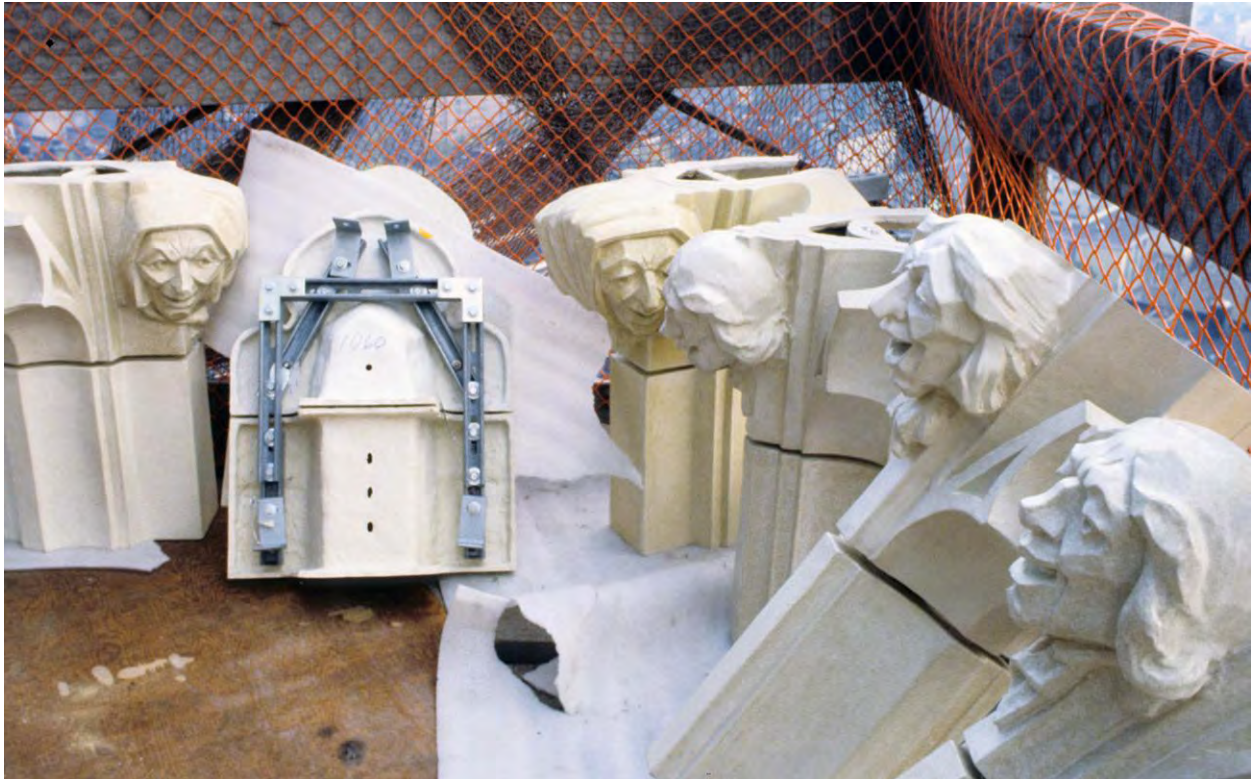
One typical application of the embedded anchors allows pre-assembly of groups of units prior to their final placement on the building. This facilitates installation where the arrangement and shapes of the parts make individual attachment difficult. Each sub-assembly is pre-assembled, test fit in place, adjusted as necessary and then installed.

- Figure 22 - Detail of embedded attachment-stainless steel threaded stud and base plate
- Figure 23 - Detail of “t-clip” attachment
- Figure 24 - Pre-assembled units using embedded attachments and channels
