16 Keynote: GRC for the Restoration of Historic Buildings

Carl Stein
Elemental Architecture, USA

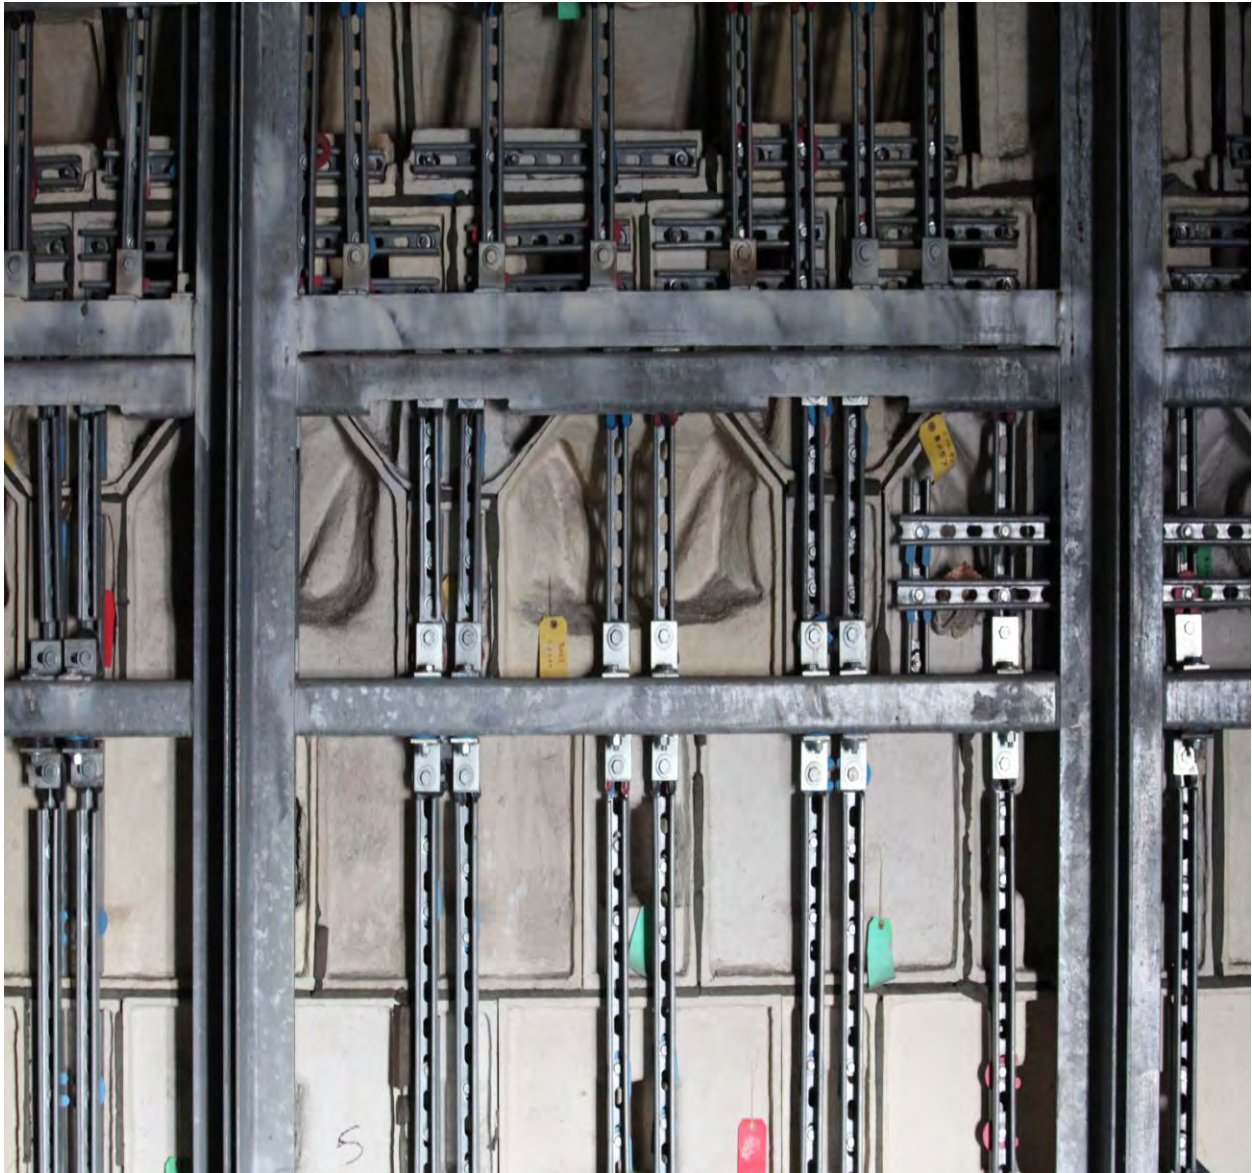
The embedded fasteners are also used where the backs of the GRC units are accessible, allowing the nuts for the threaded studs to be installed and tightened as the units are set into their final position.

- Figure 25 - Interior view of back-mounted GRC using embedded attachments (at Bell Tower)
- Figure 26 - Exterior view of GRC shown in Figure 25
- Figure 27 - GRC being installed with “T-clip” system

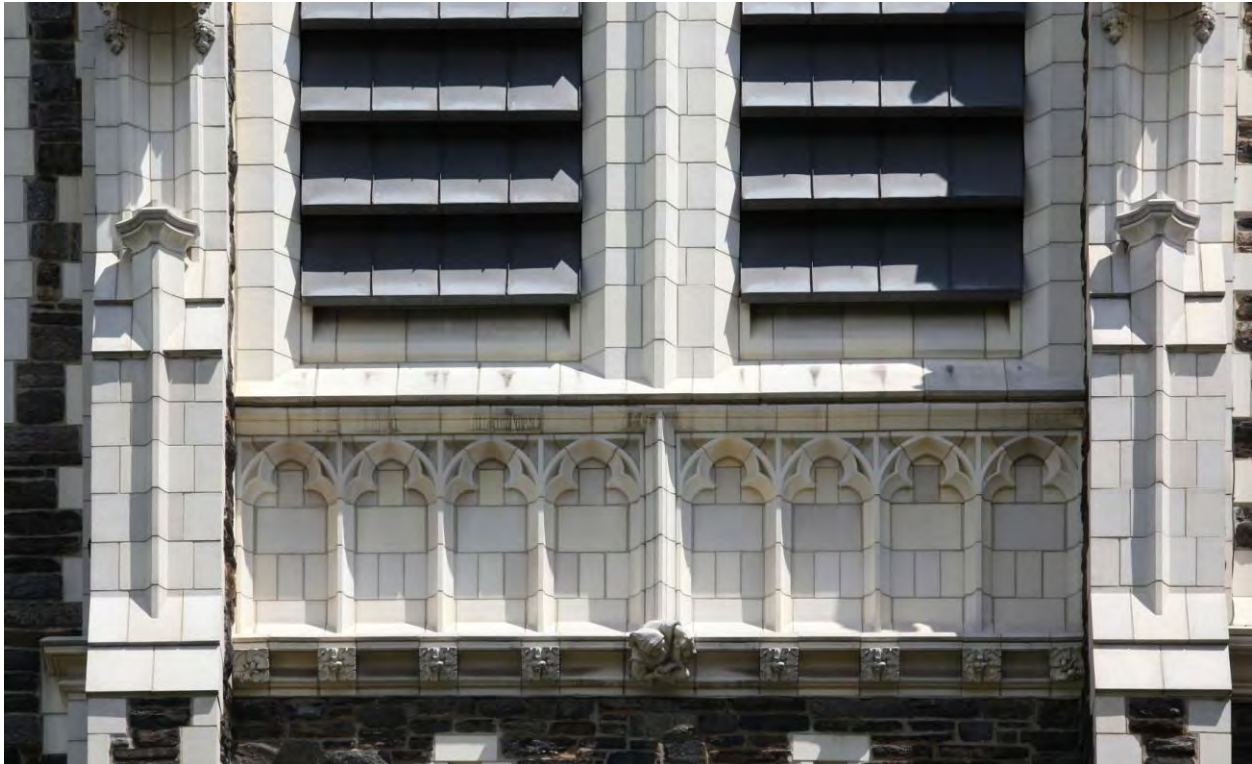
Figure 26

Note the contrast between what is clearly a thin screen assembly as is evident in the interior view and the appearance of solid masonry when seen from the exterior.

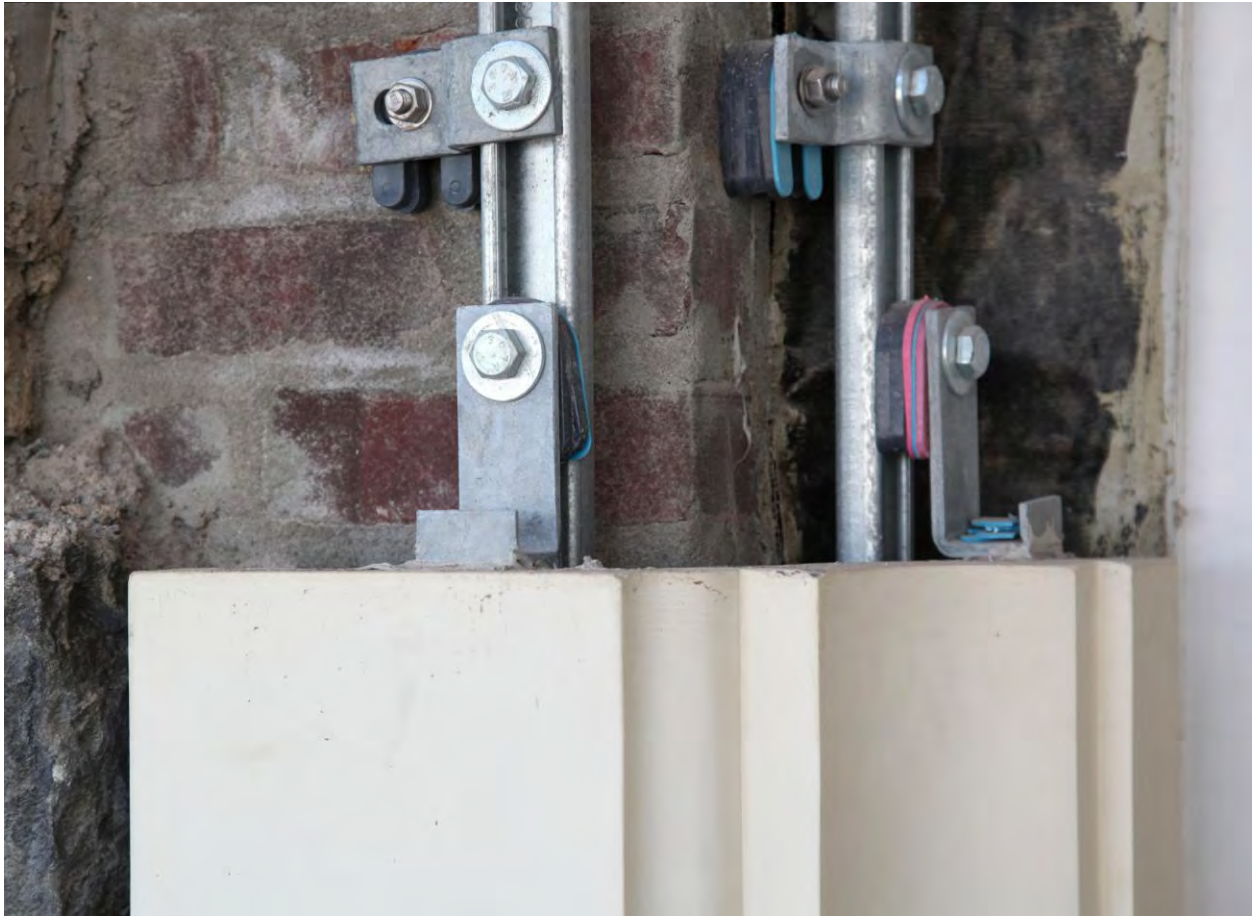
Figure 27

The slots and “L” or “T” clips are generally used where installation is from the outside face and there is no rear access.

The only disadvantages of the slot and clip system are that the installation of the GRC units must proceed sequentially, and that the connection of the final unit generally requires an access panel. For both attachment systems, full adjustment in three axes is provided by a combination of channels with sliding bolts, slotted holes and shims.

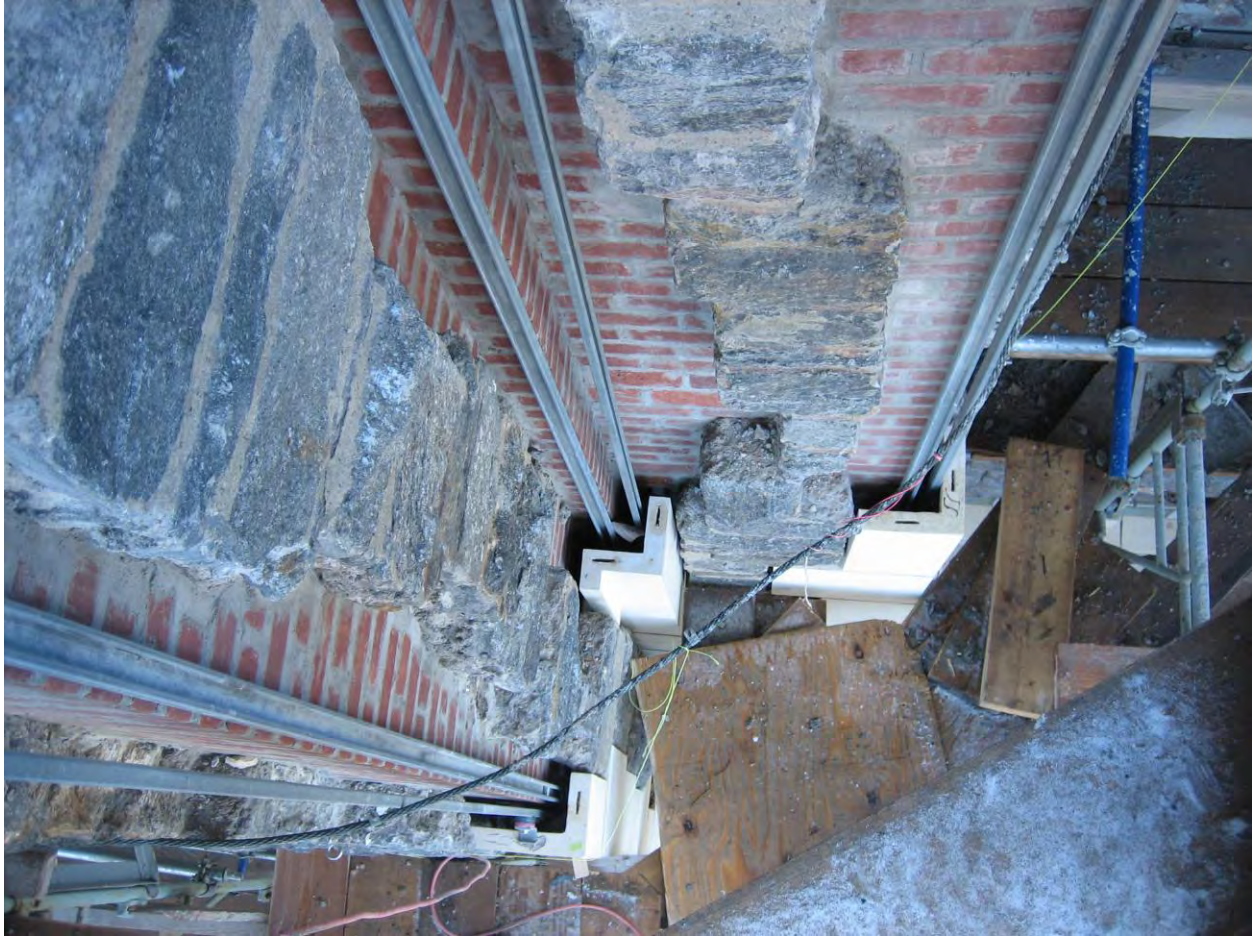
Where the GRC is being incorporated into an existing masonry surface, this plane is achieved using unit masonry which generally is filling the bulk of the void left by the removal of the original terra cotta.

- Figure 28 - New brick structure to receive channels for “T-clip” installation
- Figure 29 - New cast-in-place concrete structure at Bell Tower to receive embedded attachment installation

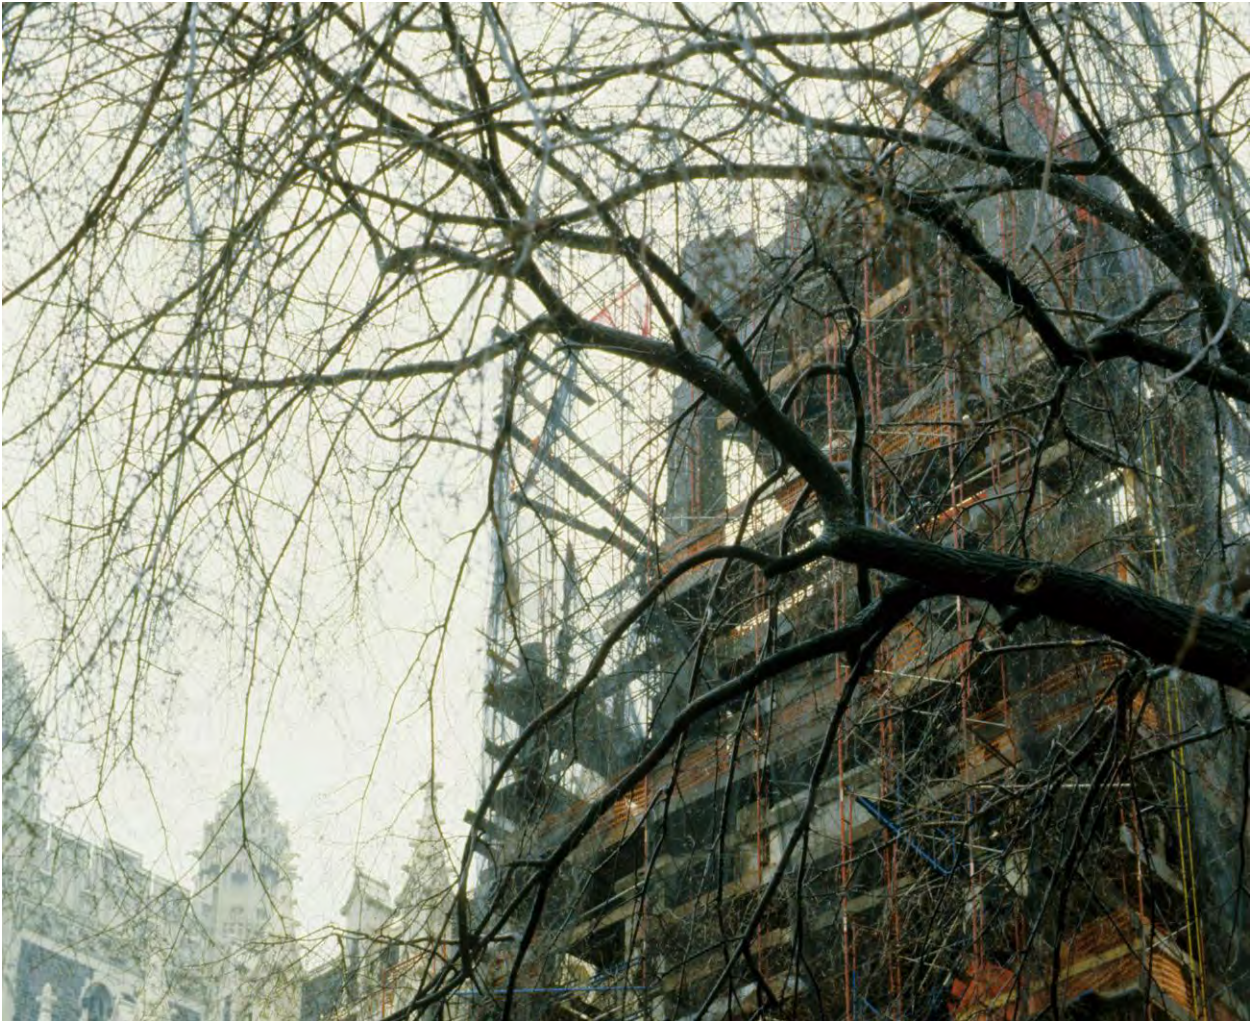
Figure 29

In areas where entire portions of the building must be completely replaced, the new structure which is typically either cast-in-place reinforced concrete...

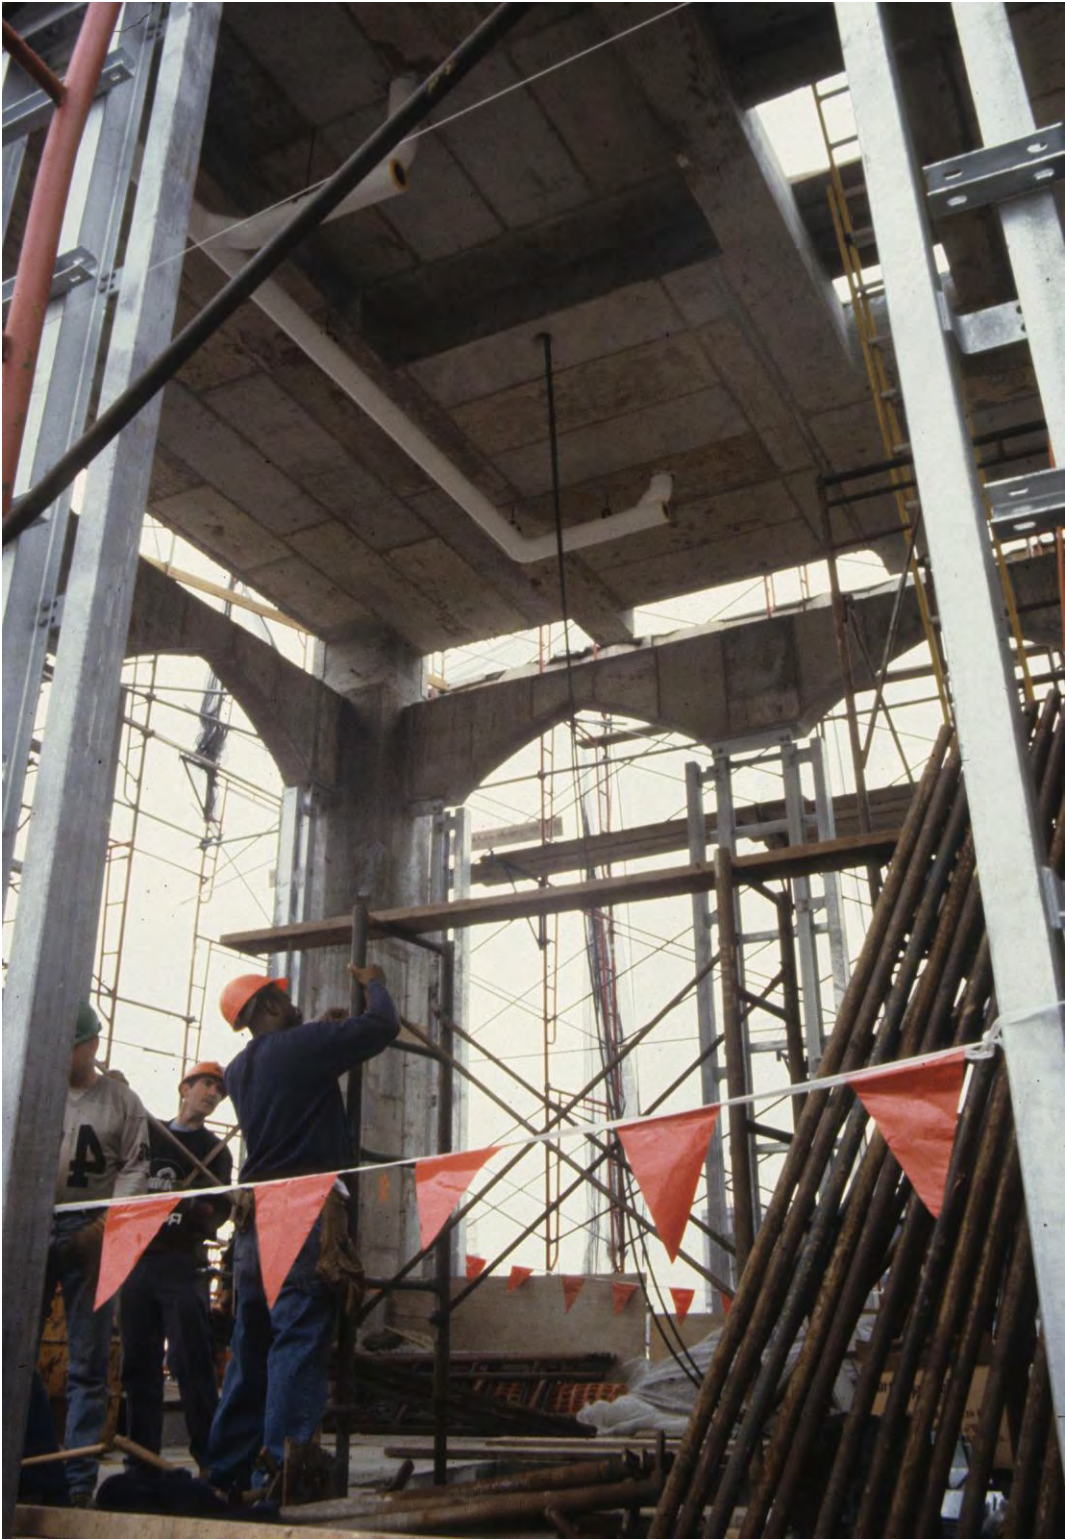
...as in the case if the upper 12 m of the Bell Tower, the area pictured in Figures 25 and 26,

- Figure 30 - New cast-in-place concrete structure at Bell Tower to receive GRC shown in Figures 25 and 26
- Figure 31 - New precast concrete structure for turret at Main Tower

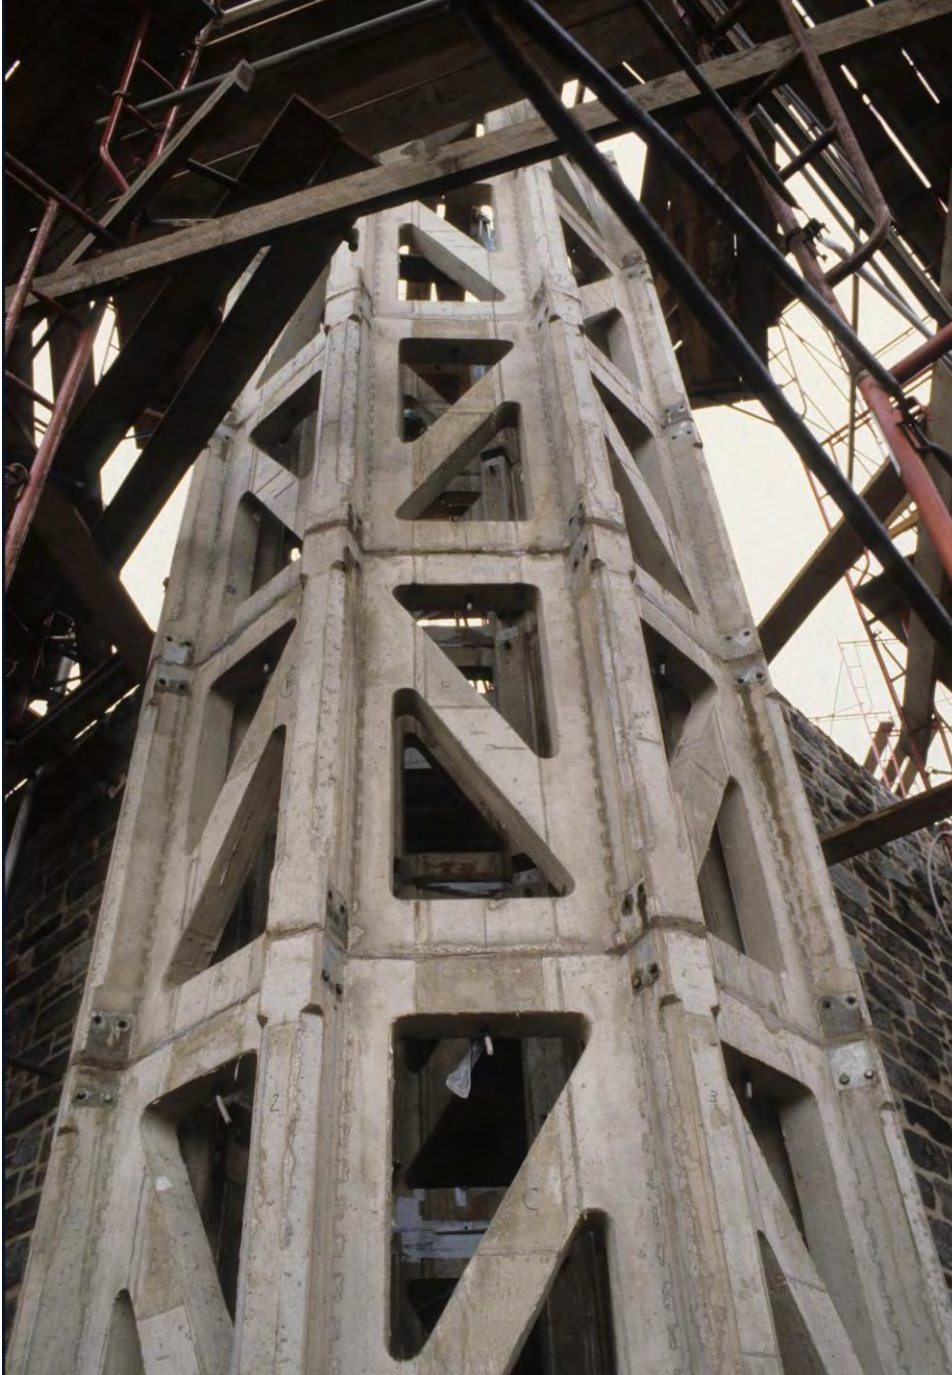
Figure 31

or in precast/post-tensioned concrete as for the upper 20 m of the Main Tower.

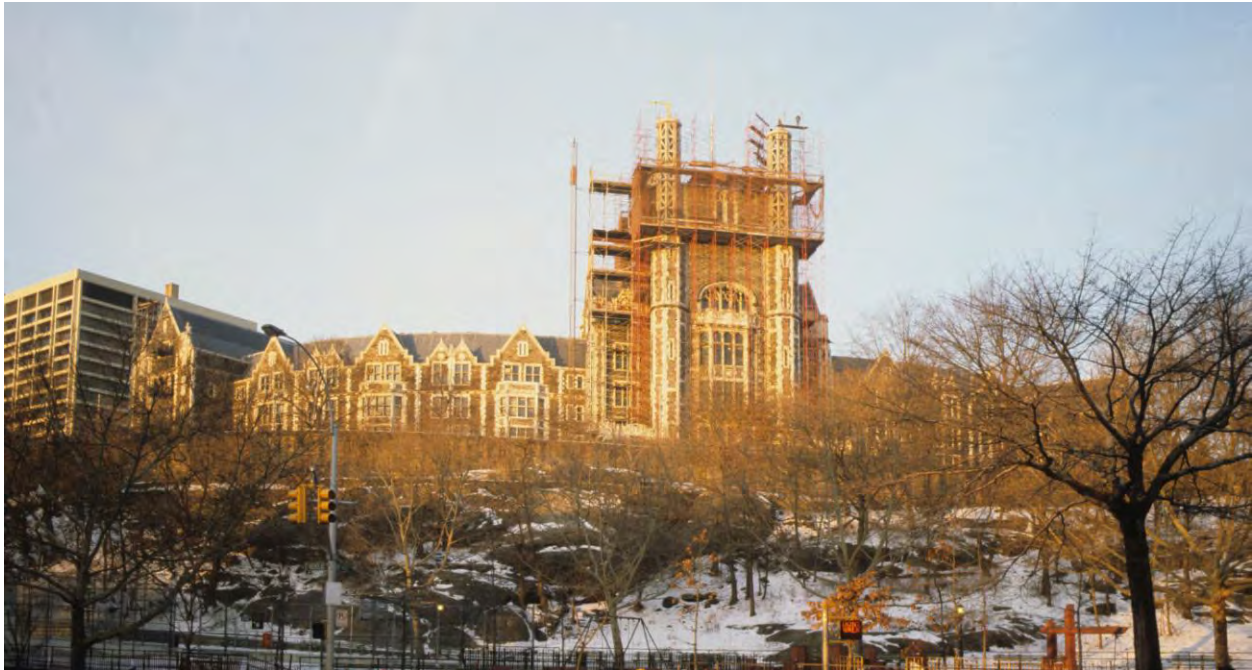
These new structural elements establish the precise reference plane that permits the design, dimensioning and fabrication of the GRC to be carried out as though this were a new building rather than a complex insertion into an irregular historic landmark.

- Figure 32 - Overall view showing new precast turret structures prior to cladding
- Figure 33 - Completed GRC installations showing work of four different projects

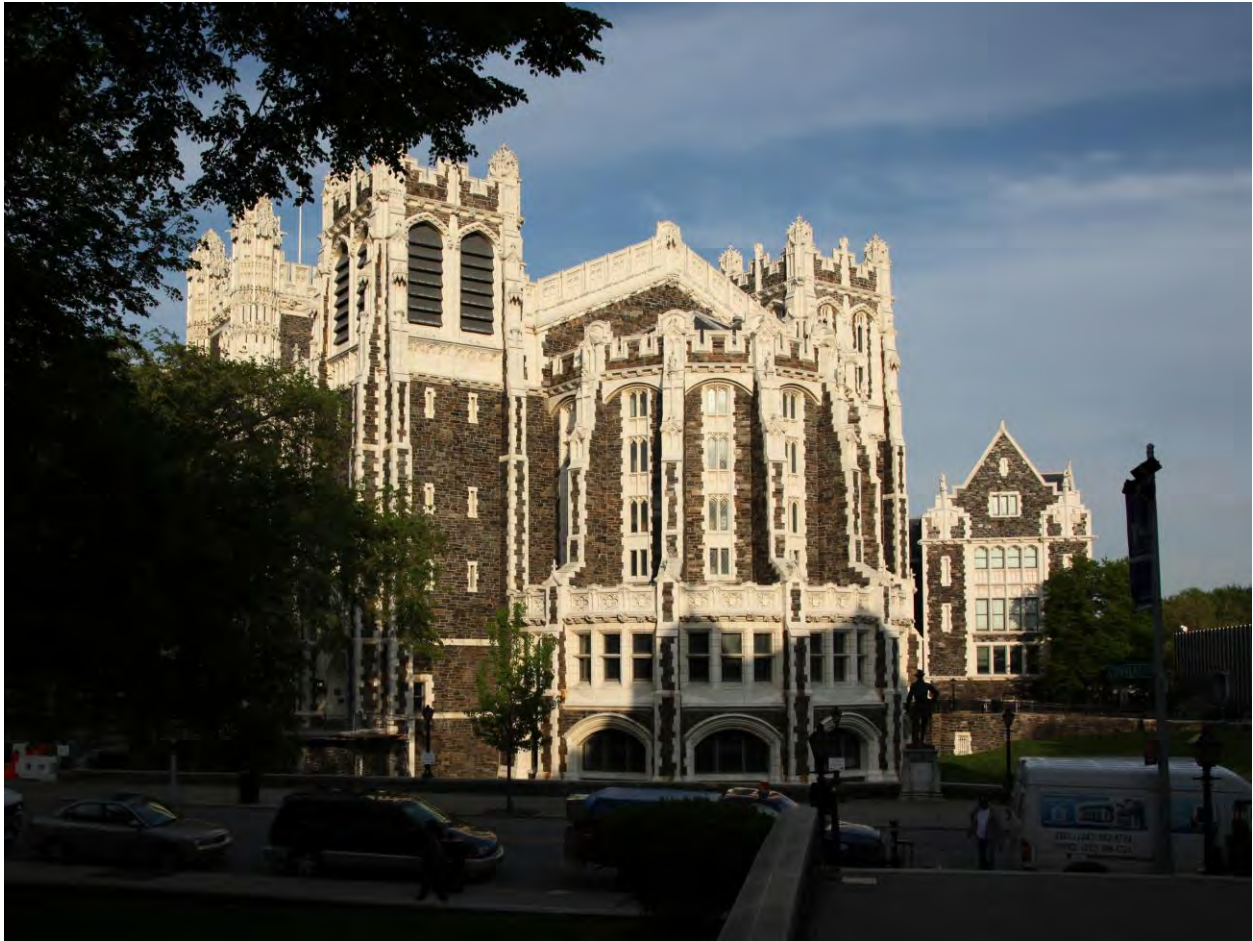
Figure 33

First and foremost, the GRC-based system developed for the reconstruction of the Shepard Hall envelope and associated structural repairs has worked extremely well.

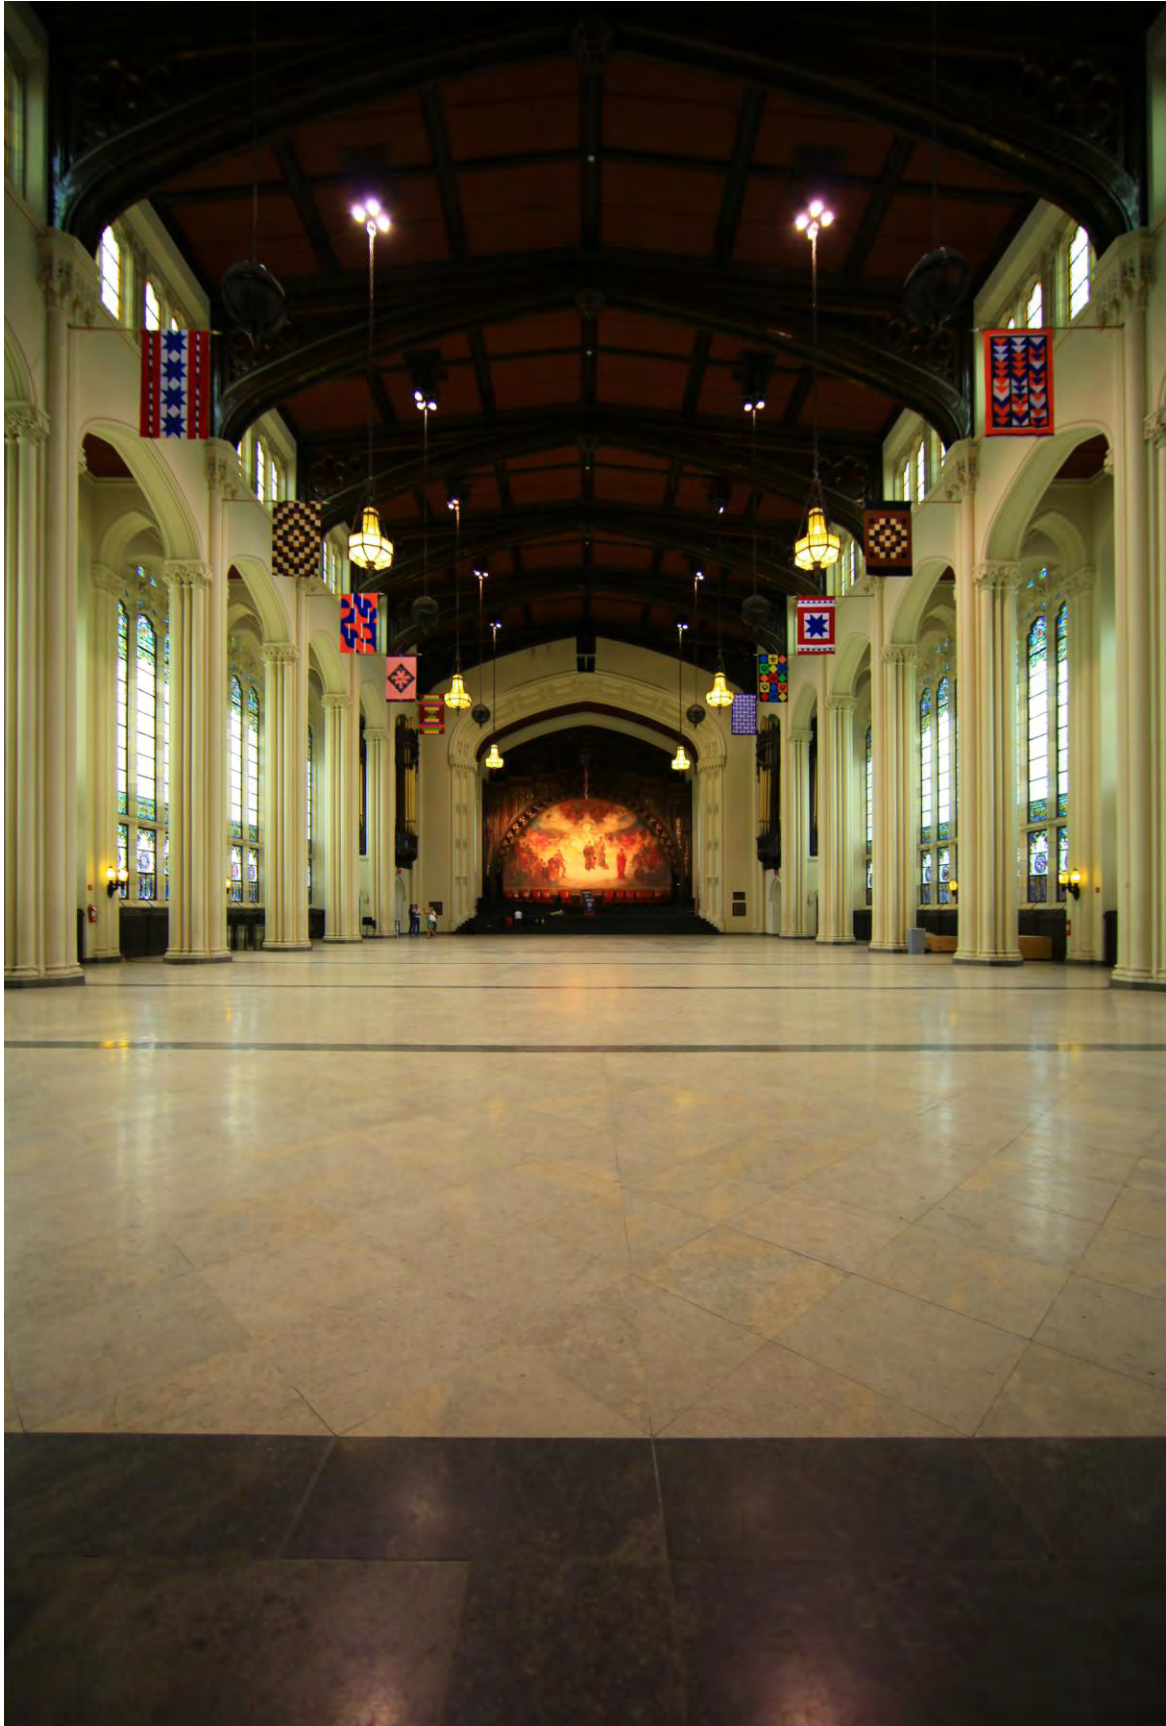
- Figure 34 - The Great Hall after renovation
- Figure 35 - GRC sculpture-2005 The “dog” finial is approximately 2 m tall.
- Figure 36 - GRC in fabrication-2011

A further benefit is that as the GRC technology has developed and become more common, the resulting cost savings have funded a number of secondary projects including the total renovation of the Great Hall.

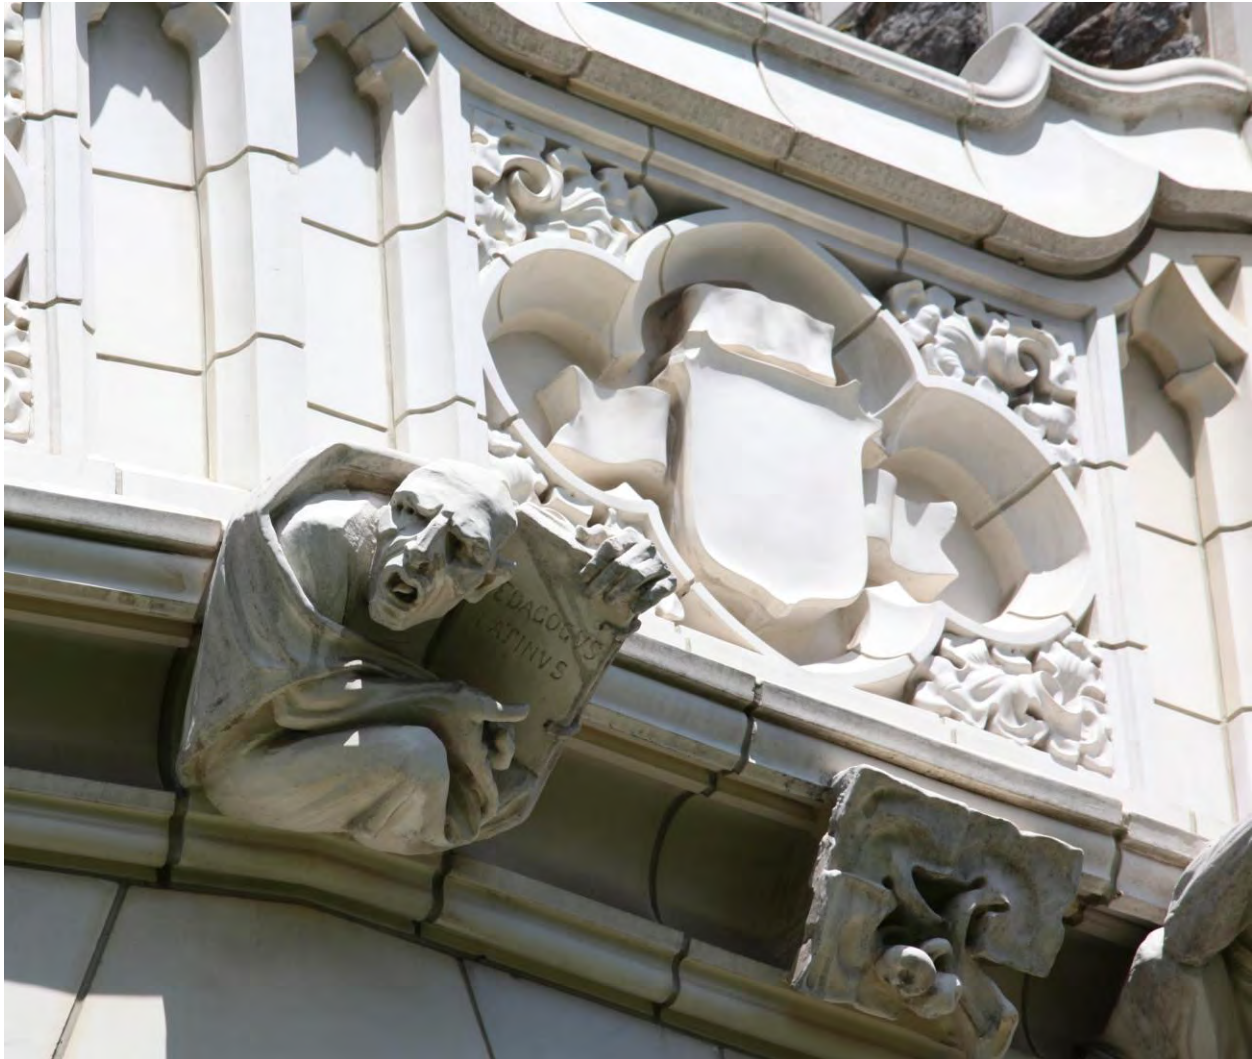
- Figure 37 - Complex GRC-2000
- Figure 38 - GRC sculpture-2002
- Figure 39 - GRC in background-1995, GRC in foreground-2004
- Figure 40 - Overall view showing work of five different projects.

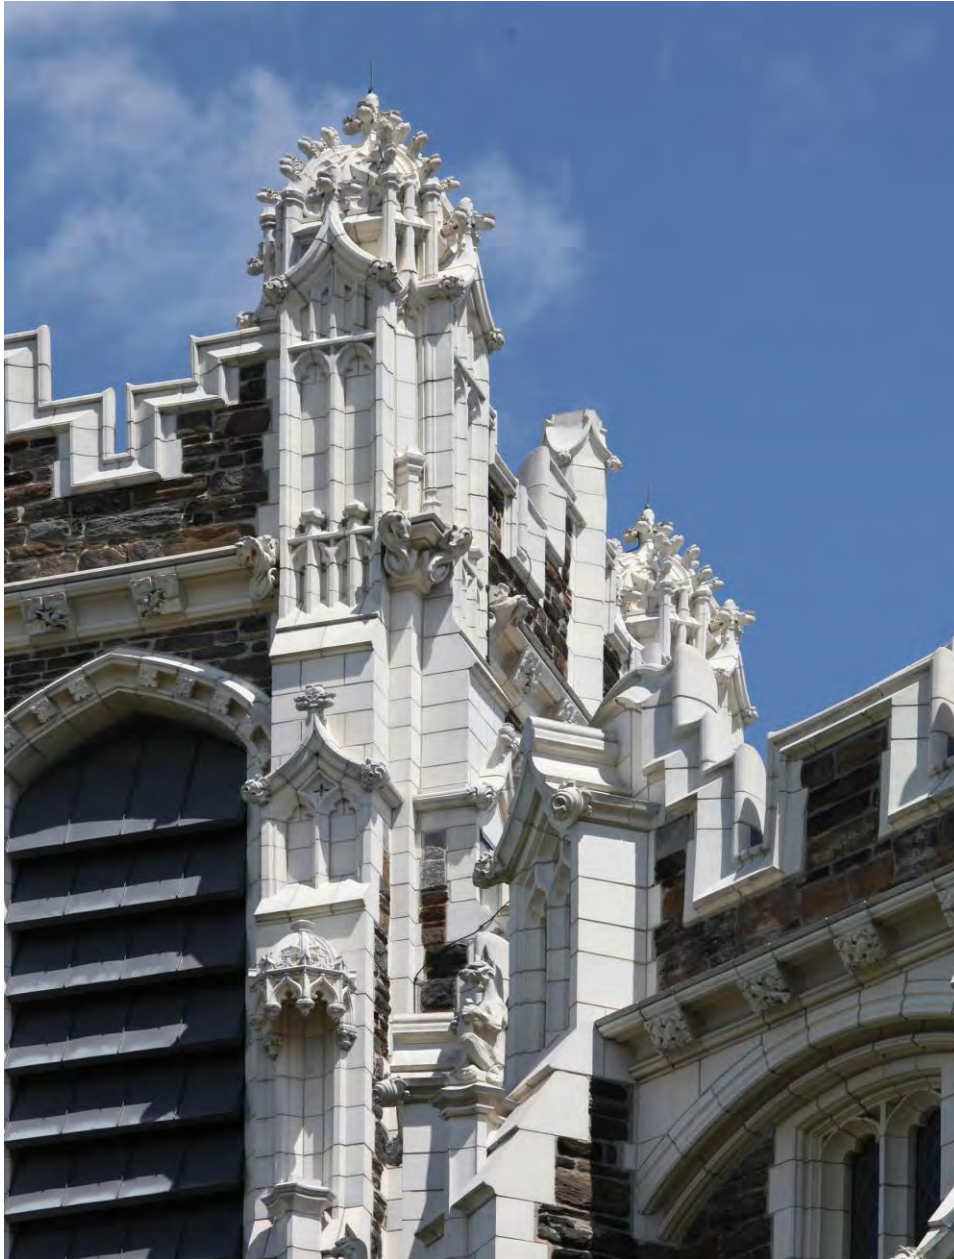
Figure 39

Here, the GRC in the background to the left was installed in 1995 while that in the foreground to the right was installed in 2005.

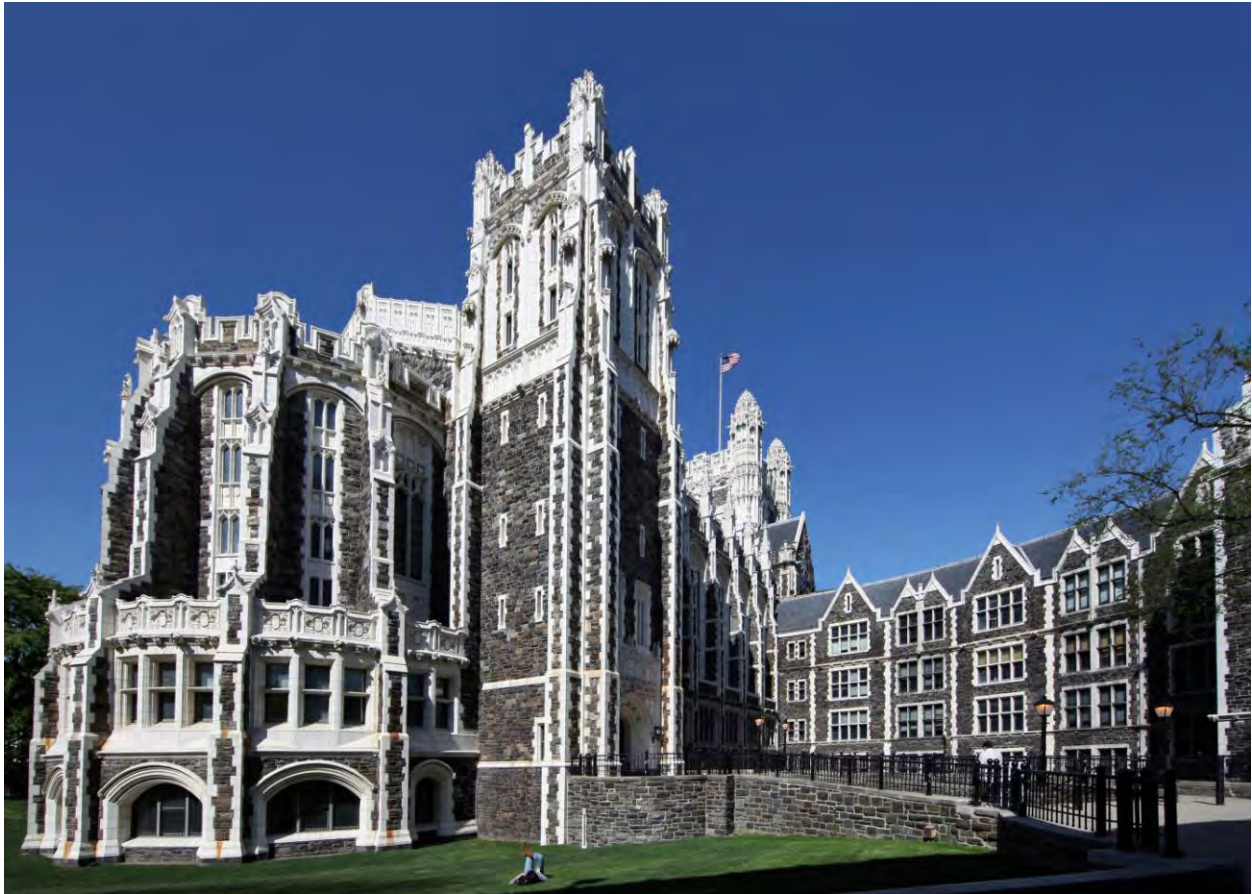
Figure 40

An important benefit to the tightly controlled GRC specification has been the ability to obtain compatible product from a number of different suppliers. This is particularly important for publicly bid and contracted work in which the material may be provided by anyone who can demonstrate compliance with experience qualifications. For example, at Shepard Hall, the fabricator for one of the medium sized projects (approximately 6,500 units) was a company specifically formed for the contract but one which employed a number of key personnel from previous phases. Another fabricator began his involvement with the Shepard Hall project by producing units for a small phase (approximately 500 units) but has continued by providing GRC for three medium sized phases. Throughout the building facade, the GRC fabrications from the various producers are almost indistinguishable from one another.
